# Burlington Tunnel Emergency Repairs: A Case History

by: K. Pidgeon - ECI Rail Constructors, Inc.  
M. Boscardin - Boscardin Consulting Engineers, Inc.  
W. Riehl, III – Rail America, Inc.

RETC - 21 June 2011  
San Francisco

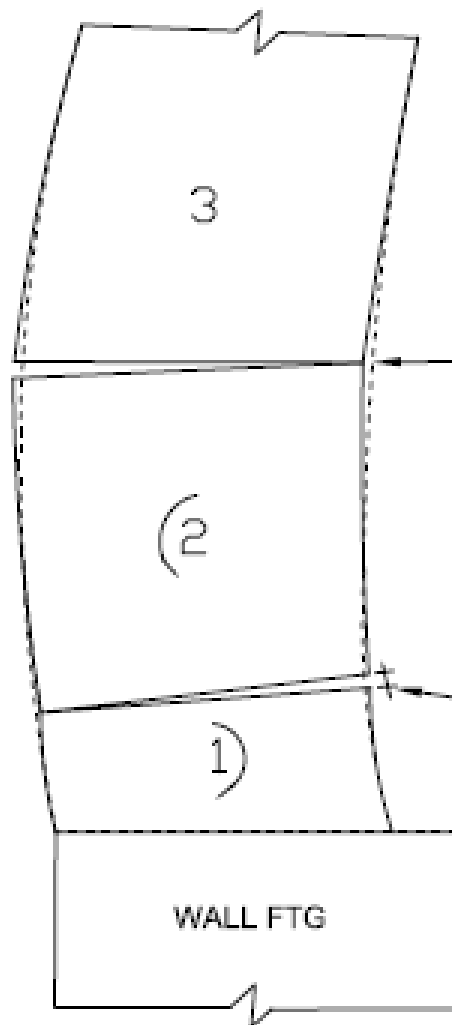
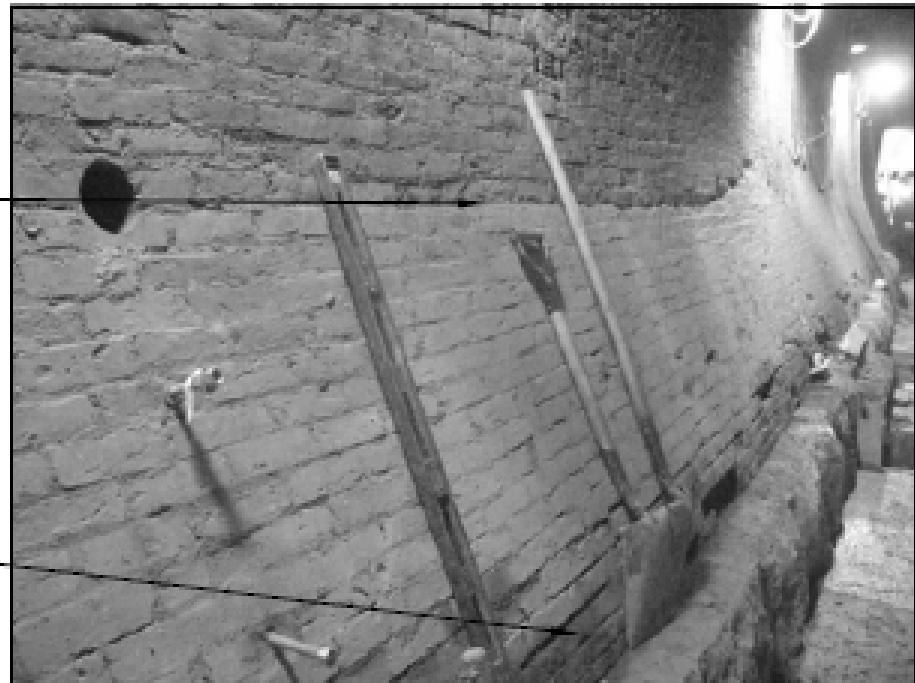
# Wall Movement

Developed Rapidly After Floor Removal

- Tunnel Sidewalls Moved Inward
- Additional Cracking Observed
- Immediate Response - Stabilize and Assess

TOP  
CRACK

LOWER  
CRACK

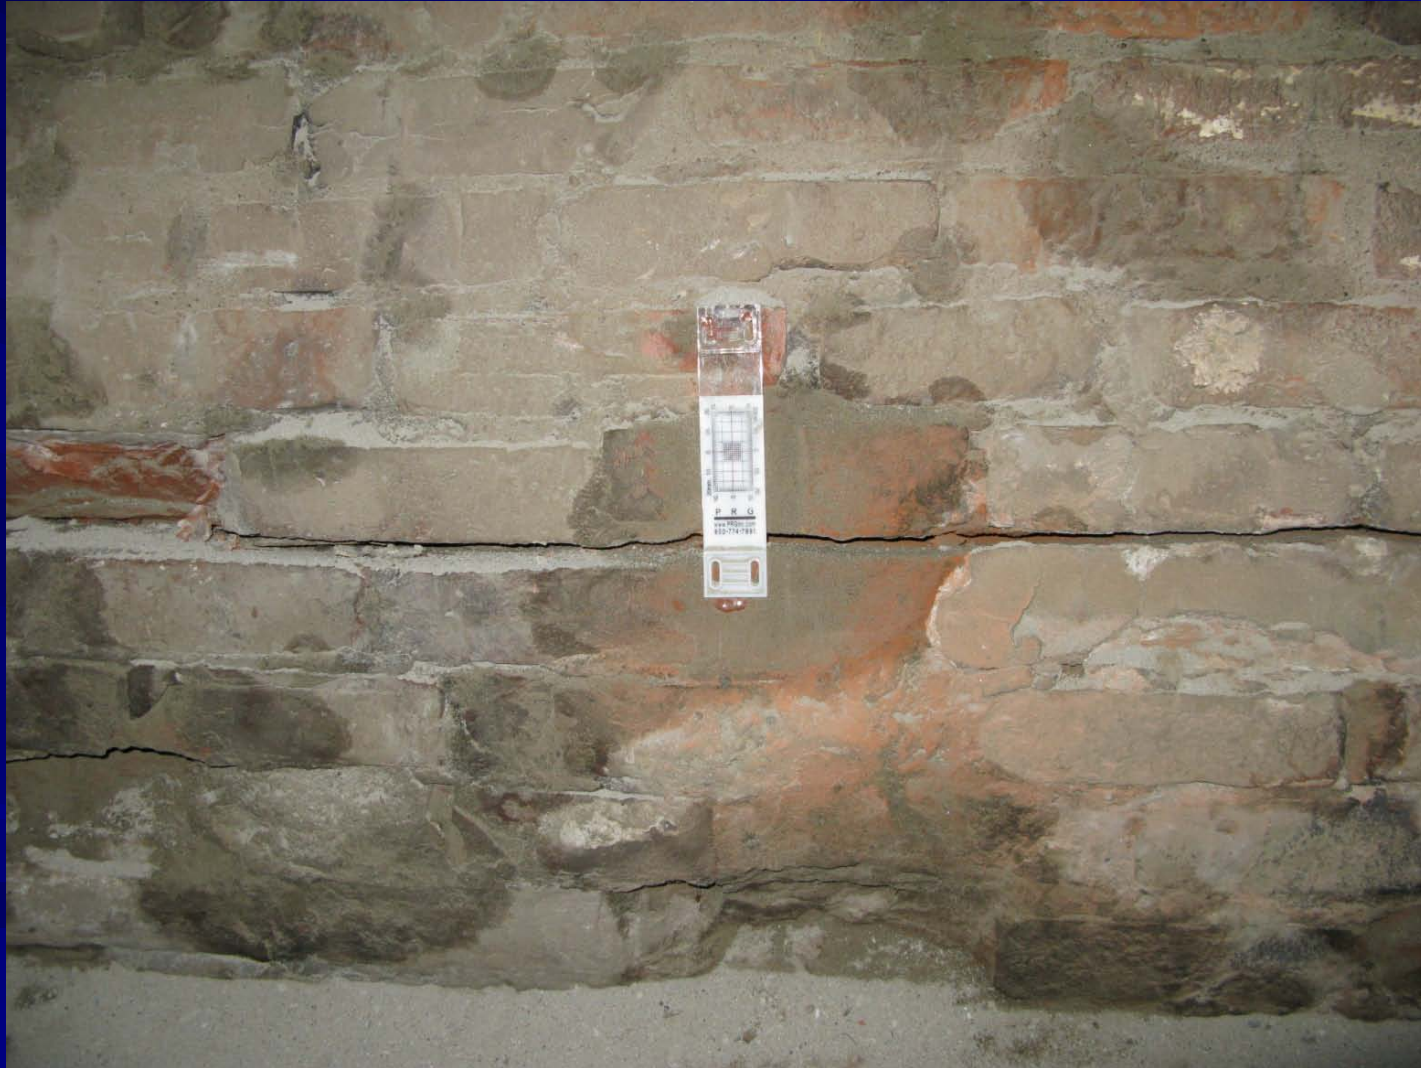
# Cracking Caused by Rehab Construction

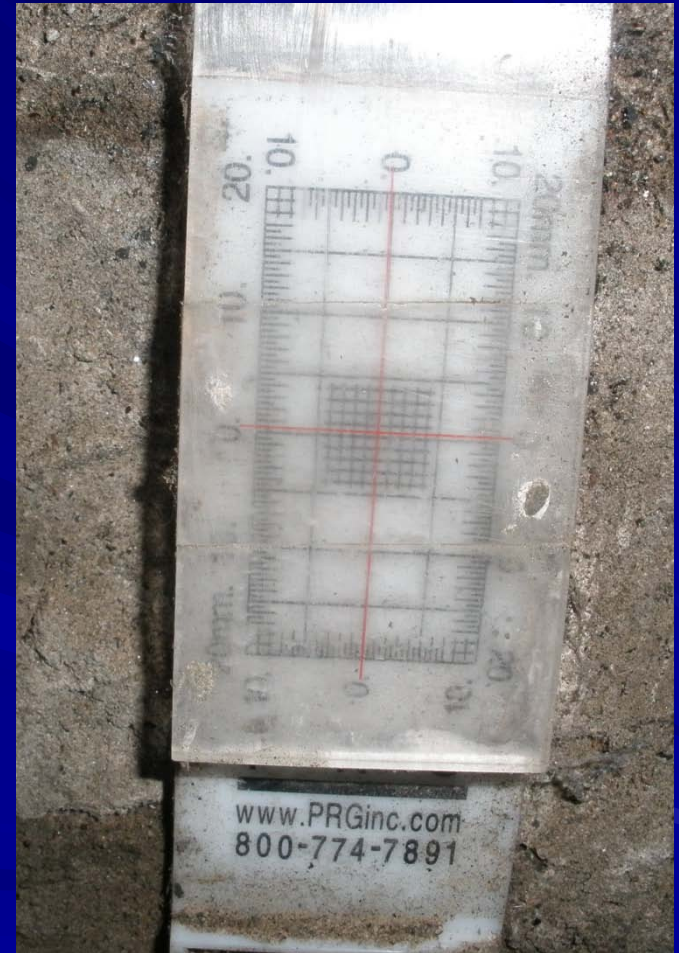
# Crack Monitor Nov 2010

- Wall Convergence 0 to 1/4 inch Since November 2008
- Typically 1/8 inch Convergence
- Approximately Equal Estimated Shrinkage of Invert Struts
- No New Cracking or Widening of Cracks Observed
