BURLINGTON TUNNEL EMERGENCY REPAIRS: A CASE HISTORY

Kenneth A Pidgeon, PE

ECI Rail Constructors, Inc., Burlington, VT

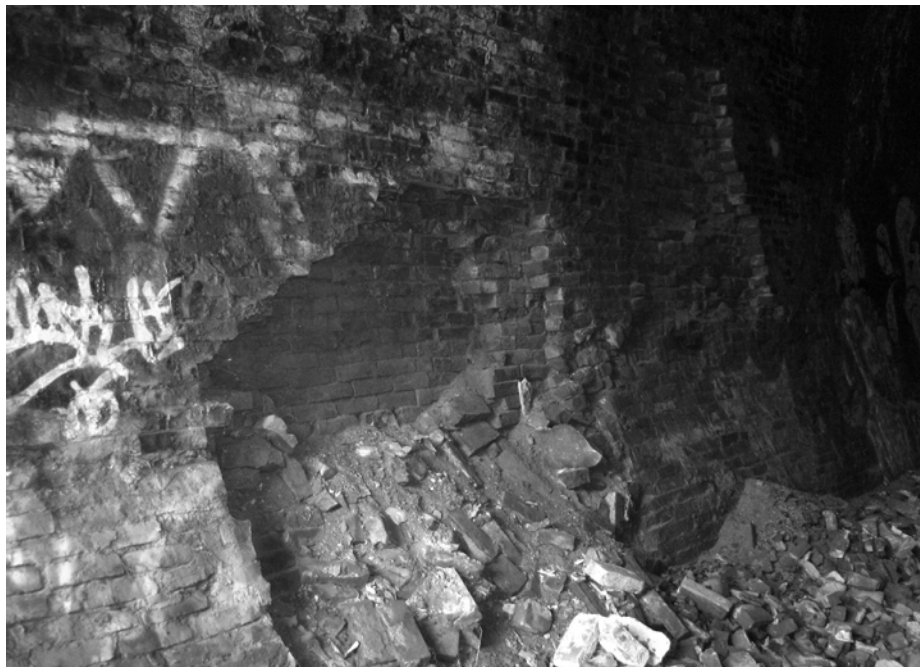
In recent years, a portion of the tunnel's brick lining had experienced significant distress due to age, weathering, surface runoff seepage, and cyclic freeze/thaw effects. Several large areas (up to 100 square ft., or more) of the walls and ceiling had lost up to three wythes of the brick lining. Figure 3 shows a photo of one of the distressed areas in 2007. The distress appears to have developed from the weathering of the mortared joints in the brick lining which caused the cement between bricks to deteriorate, leach and erode away, leaving behind sand, or voids in the joints. Eventually, the bricks fell out. The distressed areas were

Figure 3. Deteriorated brick lining in 2007

concentrated near the portals, approximately the first 7.5 to 15 m (25 to 50 ft.), apparently related to the greater number of freeze-thaw cycles and amount of surface runoff related seepage that tends to occur at the ends of the tunnel. The lining temperatures further inside the tunnel vary less in response to the daily external ambient temperature fluctuations and solar warming compared to the lining temperature near the portals.

In 2008, RailAmerica began to consider making repairs to the most severely spalled areas of the tunnel lining. Upon securing public funding, the scope was expanded to a permanent fix with 150 mm (6 in.) of shotcrete for the entire tunnel lining. However, adding a 150-mm- (6-in.-) thick layer of shotcrete also required that the tracks be lowered to compensate for the loss of clearance from the relining. The only engineering documents of the tunnel construction were a 1913 Valuation Sketch of the tunnel which indicated there might be a paved floor. Subsequent field investigation and potholing found minor stones which by size and nature were assumed to be construction debris from the original construction. Accordingly the decision was made to proceed with the track lowering and shotcrete lining. As the work progressed, the contractor encountered what we now know to be the brace floor which had been buried under the more than 150 mm (6 in.) of ballast under the ties. In addition, while the overburden is generally sand in nature, the contractor encountered zone of expansive clay that was not identified during the exploratory excavations. Serious stability problems for the foundation stones soon developed as the contractor operated equipment over this section of exposed subgrade and caused significant cracking of the brick lining.

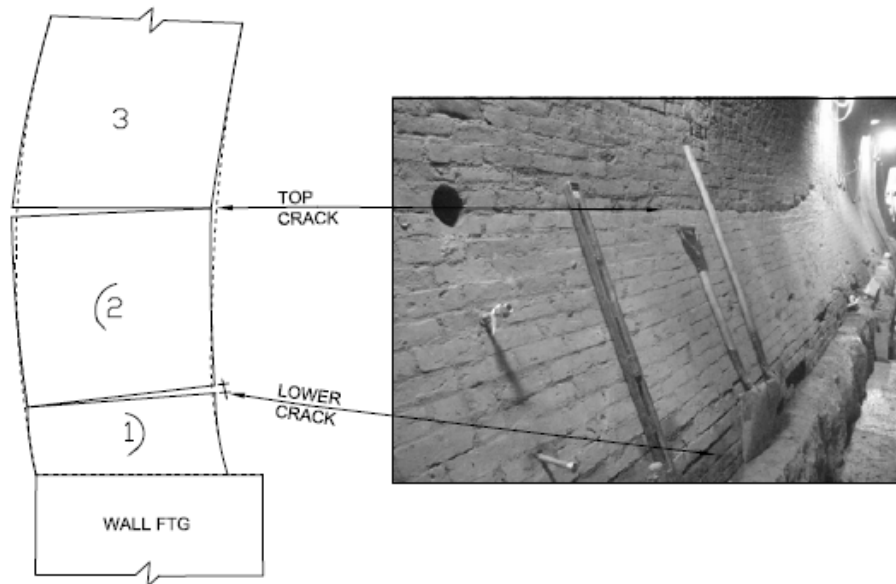
Figure 4. South wall cracking

As indicated in Figure 4, the lower portion of the tunnel wall fractured in two locations and each section rotated in opposite directions forming two distinct longitudinal cracks. The upper crack (about 1.07 m (42 in.) above the wall footing) was a pinching condition at the lining surface while the lower crack (about 230 to 300

mm (9 to 12 in.) above the wall footing) opened up to about 10 mm (3/8 in.) wide at the surface of the lining. The cracks extended longitudinally through the middle third of the tunnel (where the subgrade was also disturbed) and on the south side only (inside curve). One hundred-mm- (4-in.-) diameter cores into the lining confirmed that the cracks extended through the entire lining depth.

We surmise that the wall movements were likely the combined result of: 1) the removal of the cobblestone floor which acted as a brace at the tunnel invert, 2) the disturbance and vibration of the saturated subgrade from heavy equipment which reduced the soil/footing interface friction and passive soil resistance below the floor that helped to stabilize the tunnel, and 3) heaving and lateral displacement of the disturbed soil below the wall footing as the equipment moved through the tunnel multiple times. Cause #3 most likely resulted in observed rotation of the intact lining sections and crack arrangements (Figure 4), which cannot be explained by lateral thrust movements alone.

The railroad undertook immediate emergency action to stabilize the tunnel with an unreinforced ready-mix concrete brace slab between the wall footings at the tunnel invert to provide temporary stability until a permanent repair could be designed and implemented. The emergency slab was poured only over the middle third of the tunnel where the crack and disturbed subgrade was observed. Subsequently, ECI Rail Constructors was engaged by RailAmerica to assess the tunnel and design and construct the permanent repairs. Boscardin Consulting was hired by ECI to assist in the assessment and to provide technical recommendations. In true railroad expedited fashion, the entire repair including the shotcrete operation was completed in 2 months. The timeline of events is summarized in Table 1.

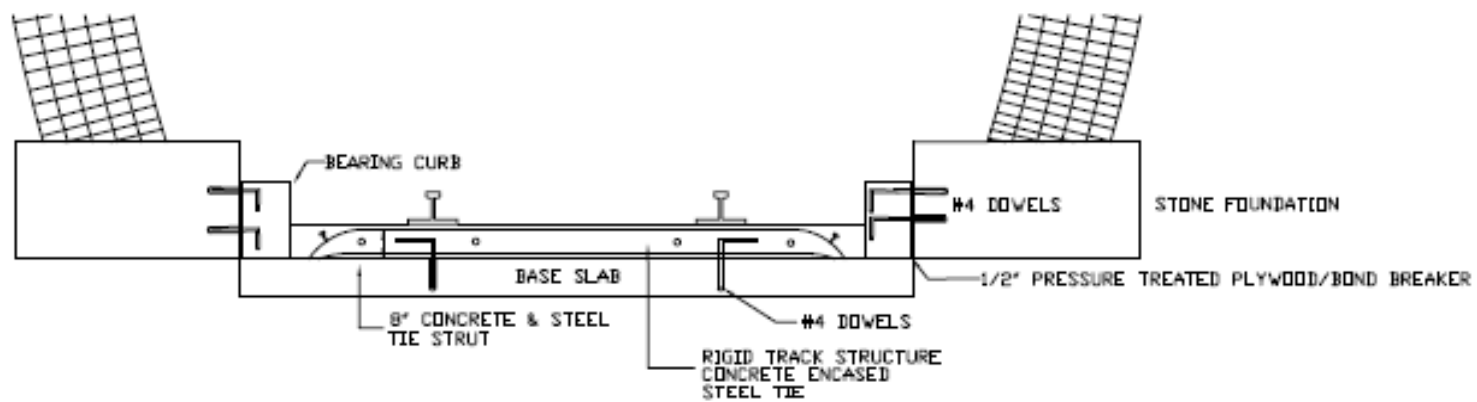
Figure 5. Repair section at center of tunnel

The resulting design, as shown in Figure 5, consisted of a rigid track structure to serve as both the track support and as the lateral brace. The design included a 250-mm- (10-in.-) thick reinforced concrete base slab

(for improved bearing on the disturbed subgrade); and a 230-mm- (9-in.-) thick layer of crushed stone (to replace some of the disturbed soil). The base slab was only installed in the middle section of tunnel (section that had experienced the movements and cracking) and was constructed in 1.8-m- (6-ft-) long segments to maintain the capacity of the emergency brace slab until the new base slab and temporary shoring was installed.

The rigid track structure was designed for 416 kN/m (28.5 kips/ft.) brace load and consists of concrete encased steel cross-ties. The steel cross-ties are Narstco H12 which are 2.6-m (8-ft-6 in.) ties with a total weight of 91 kg (201 lbs.) each (about 0.02 kN/m or 23.6 lb/ft). The steel thickness in the cross-ties is 12 mm (0.472 in.) and the cross-ties are curled down at the ends. We installed headed studs at the curled down ends to assure adequate stress transfer to the steel member (refer to Fig 5). The ties were attached together with a series of steel reinforcing bars welded to the cross-ties. The rail consists of jointed, 45 kg (100 lbs.) RA and is continuously anchored to the cross-ties with rail clips.

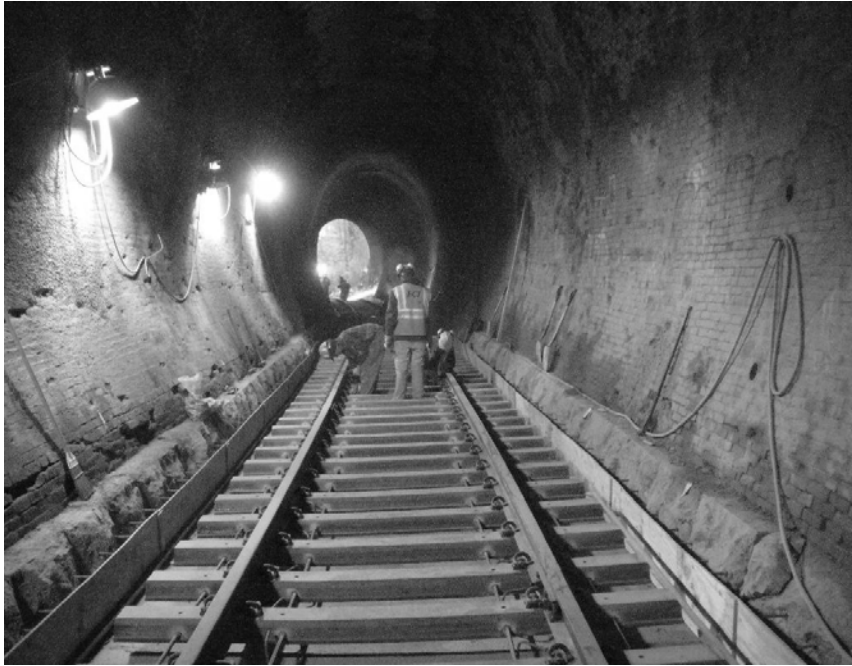
Figure 6. Rigid track structure being assembled

The rigid track structure had special installation considerations because once the steel cross-ties were concrete encased, the track alignment was essentially permanent. The alignment of the new track within the existing 4° horizontally curved tunnel needed to consider both the reduced side and ceiling clearances from the shotcrete and occasional irregularities of the tunnel. In practice, this complexity was made even more difficult because the rails were superelevated 25 mm (1 in.) throughout the curve and because the longer rail cars encroach even further on the limits of a clearance envelope (imagine chords on a horizontal curve). These factors made it necessary to: 1) assemble the entire track, 2) align the track, and 3) verify clearances with an actual rail car – all prior to casting the concrete of the rigid track structure. In order to meet this objective, the rigid track structure (the permanent brace) needed to be installed after the base slab, rather than segmentally which would have been the best method to maintain continuous bracing during removal of the emergency brace slab. Installing the complete base slab first provided a stable base to work from and assemble the steel cross-ties and rail (as shown in photo in Figure 6). However, it did not provide a direct lateral brace to the tunnel wall footings since there was not enough remaining height of the footings to engage with the base slab. It was anticipated that some additional temporary lateral shoring posts would be necessary throughout the middle section until the rigid track structure could be installed.

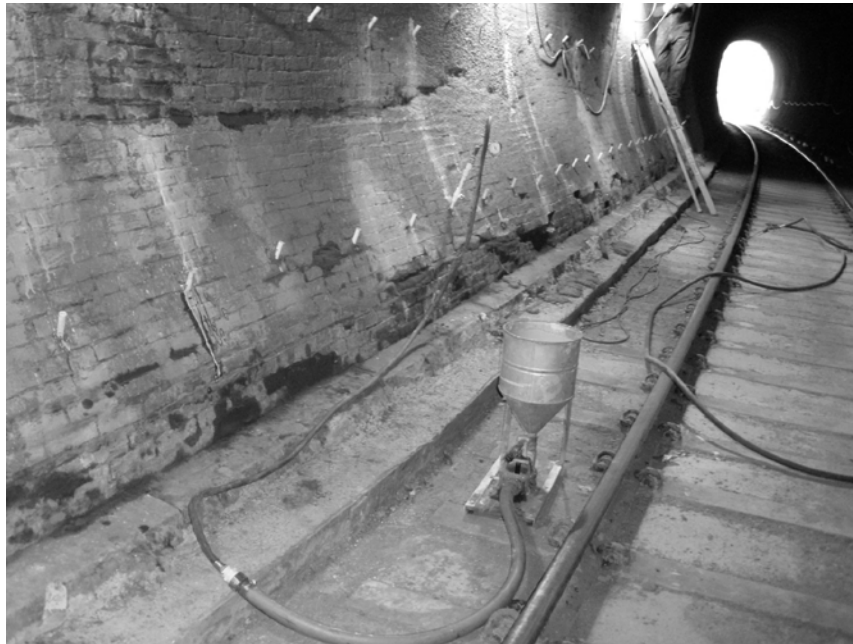
Figure 7. Grouting cracked lining

The final phase of the repair was the grouting of the tunnel lining at the crack locations to fill the crack voids thereby restore full bearing across the thickness of the lining and limiting the potential for stress concentrations and related spalling. This work (shown in Figure 7) was done after the tunnel was put back into railroad service. The grouting program consisted of two rows of 12-mm- (1/2in.-) diameter grout holes at a 600-mm- (2-ft.-) horizontal spacing. Each row of grout holes was drilled into the brick lining at a 45° angle above each crack so to intercept the cracks about midway through the lining. The grout was pumped with a Kendrick GP-1 hand operated pump to better control the grout pressure to the 28 kPa (4 psi) maximum criterion. The grout was hand-mixed and consisted of deNeef MC500 Microfine Cement with NS200 Dispersant. Grout holes were injected once in a zoned primary/secondary sequence. The grout takes ranged from 0 to 12.3 l (416 fl. oz.) per hole with an aggregate total of 118 l (4000 oz.).
