GMRR Bridge #114
Tropical Storm Irene Emergency Repairs
Chester, Vermont

ECI Rail Constructors, Inc.
September 2011

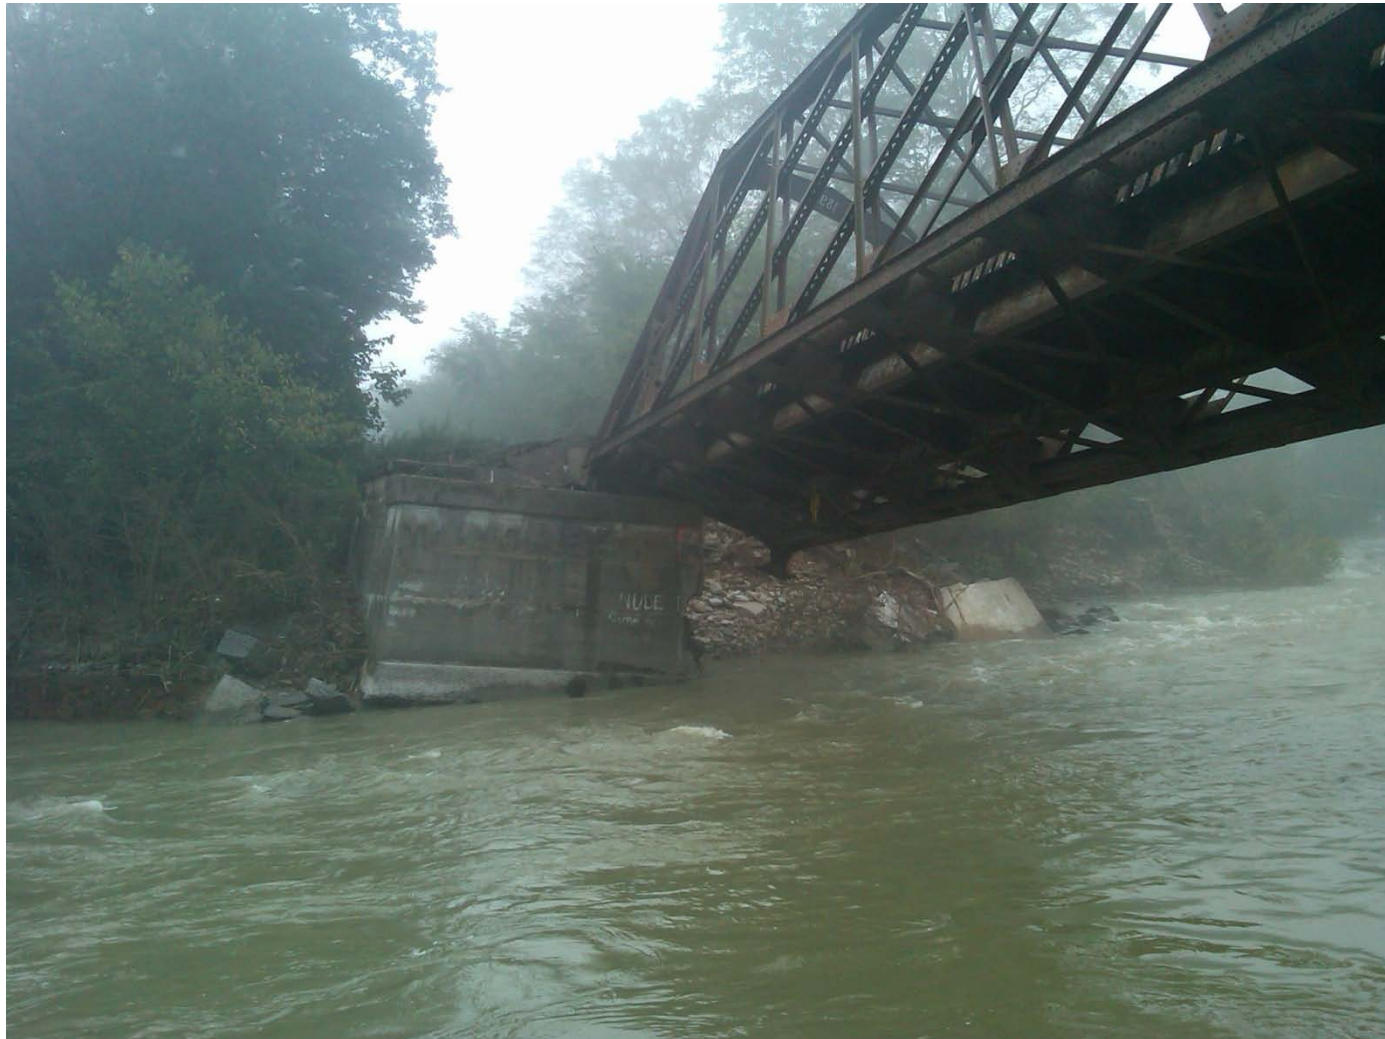
Initial ECI Site Visit Tuesday – August 31

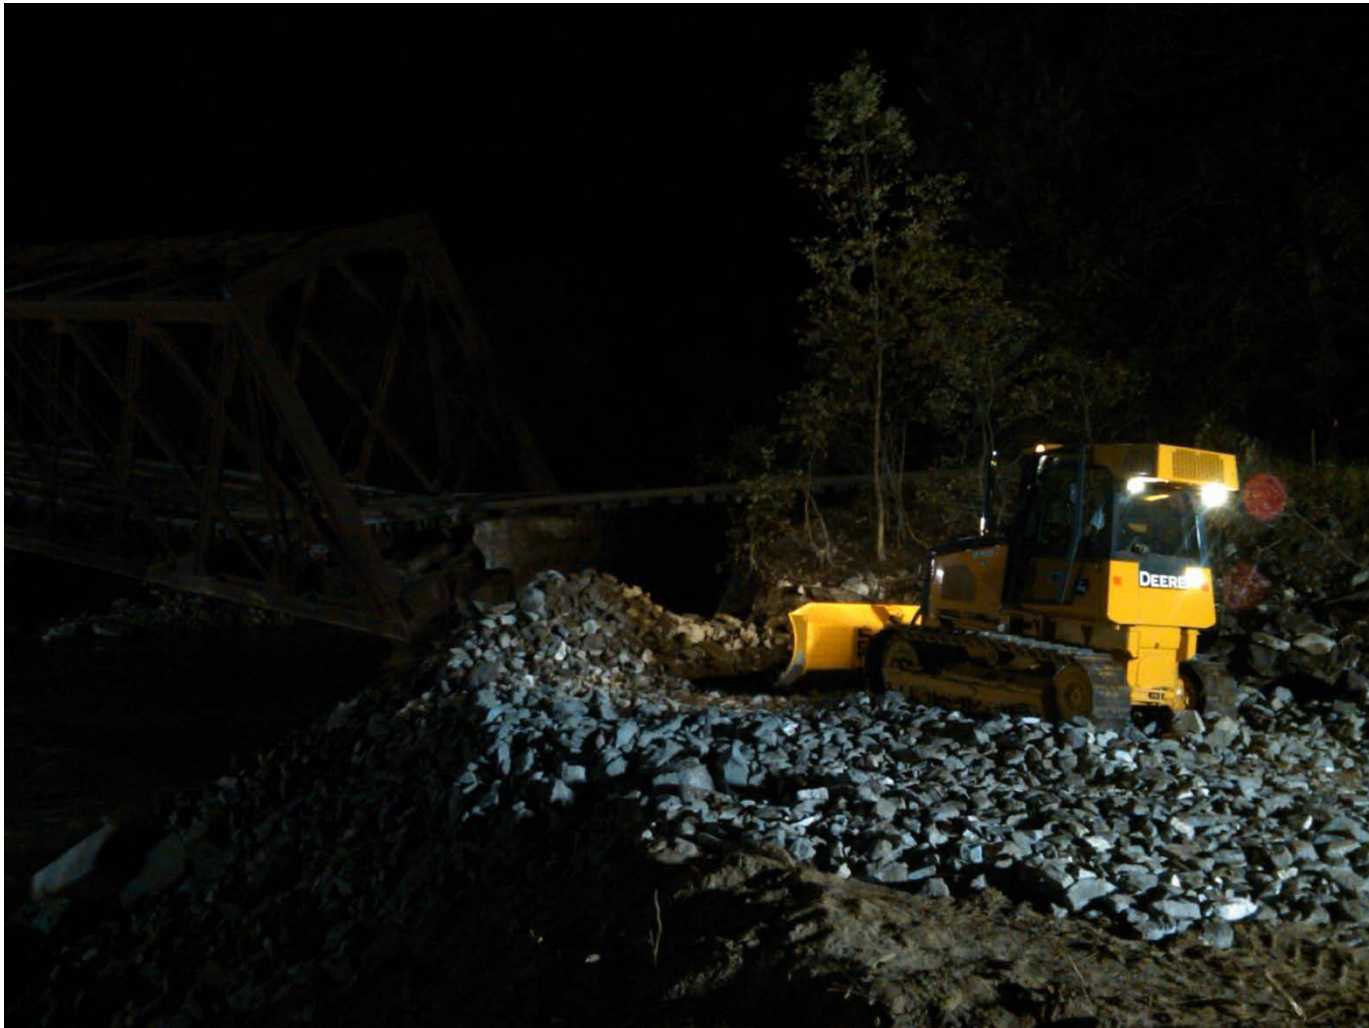
Mobilization & Access Construction

Wed-Sat: Sept 1 to Sept 3

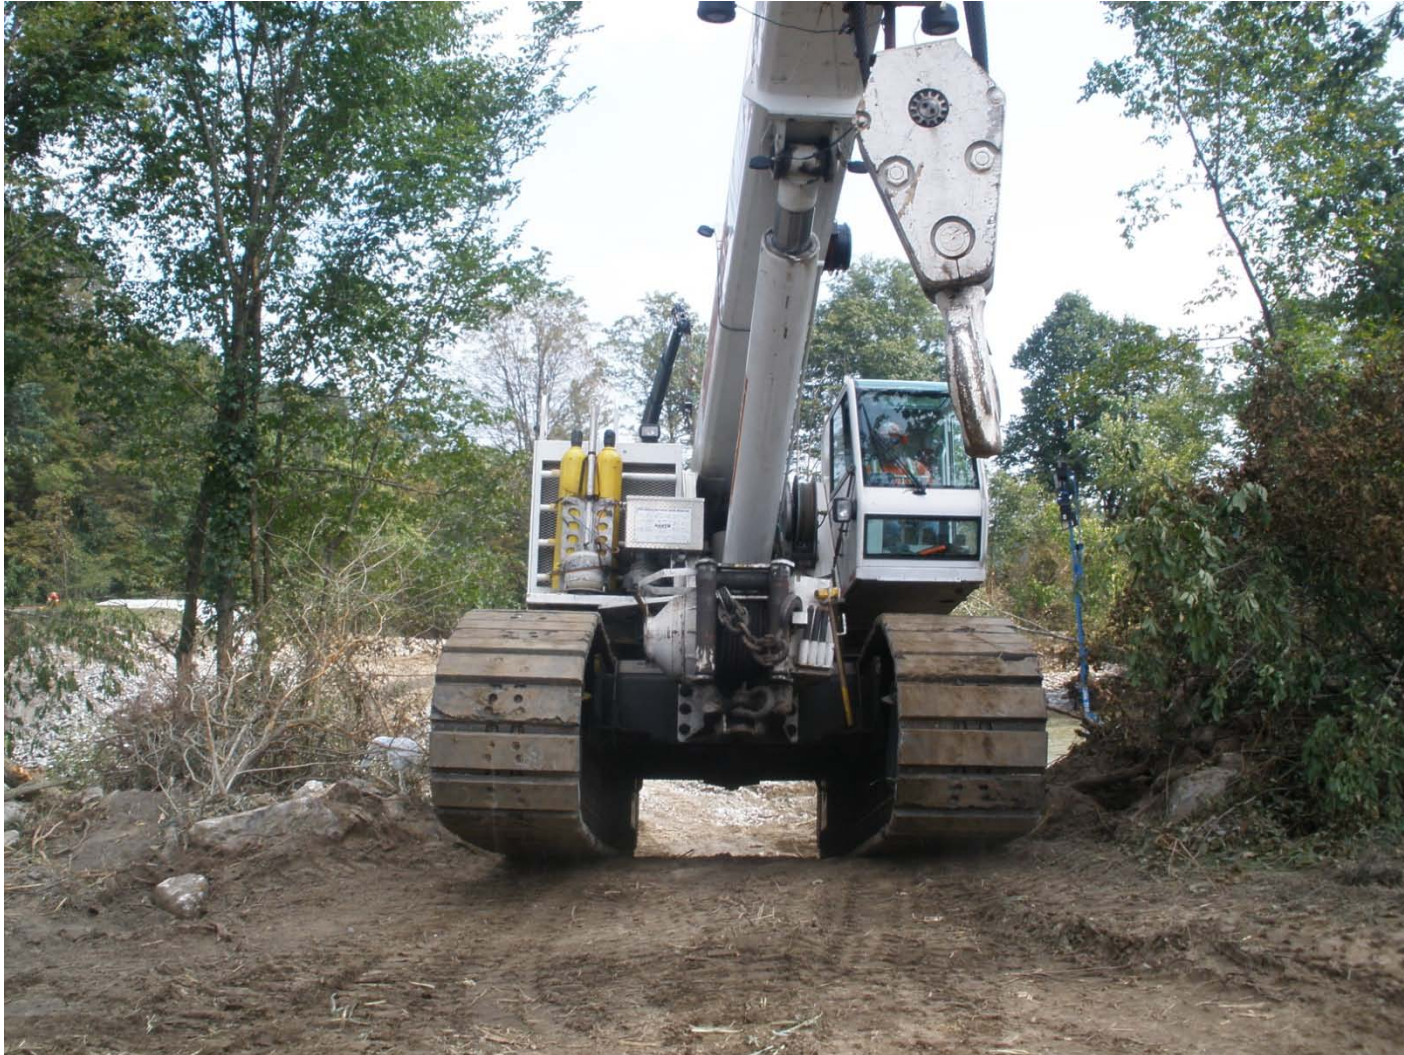
Mobilize Cranemasters Saturday – September 3

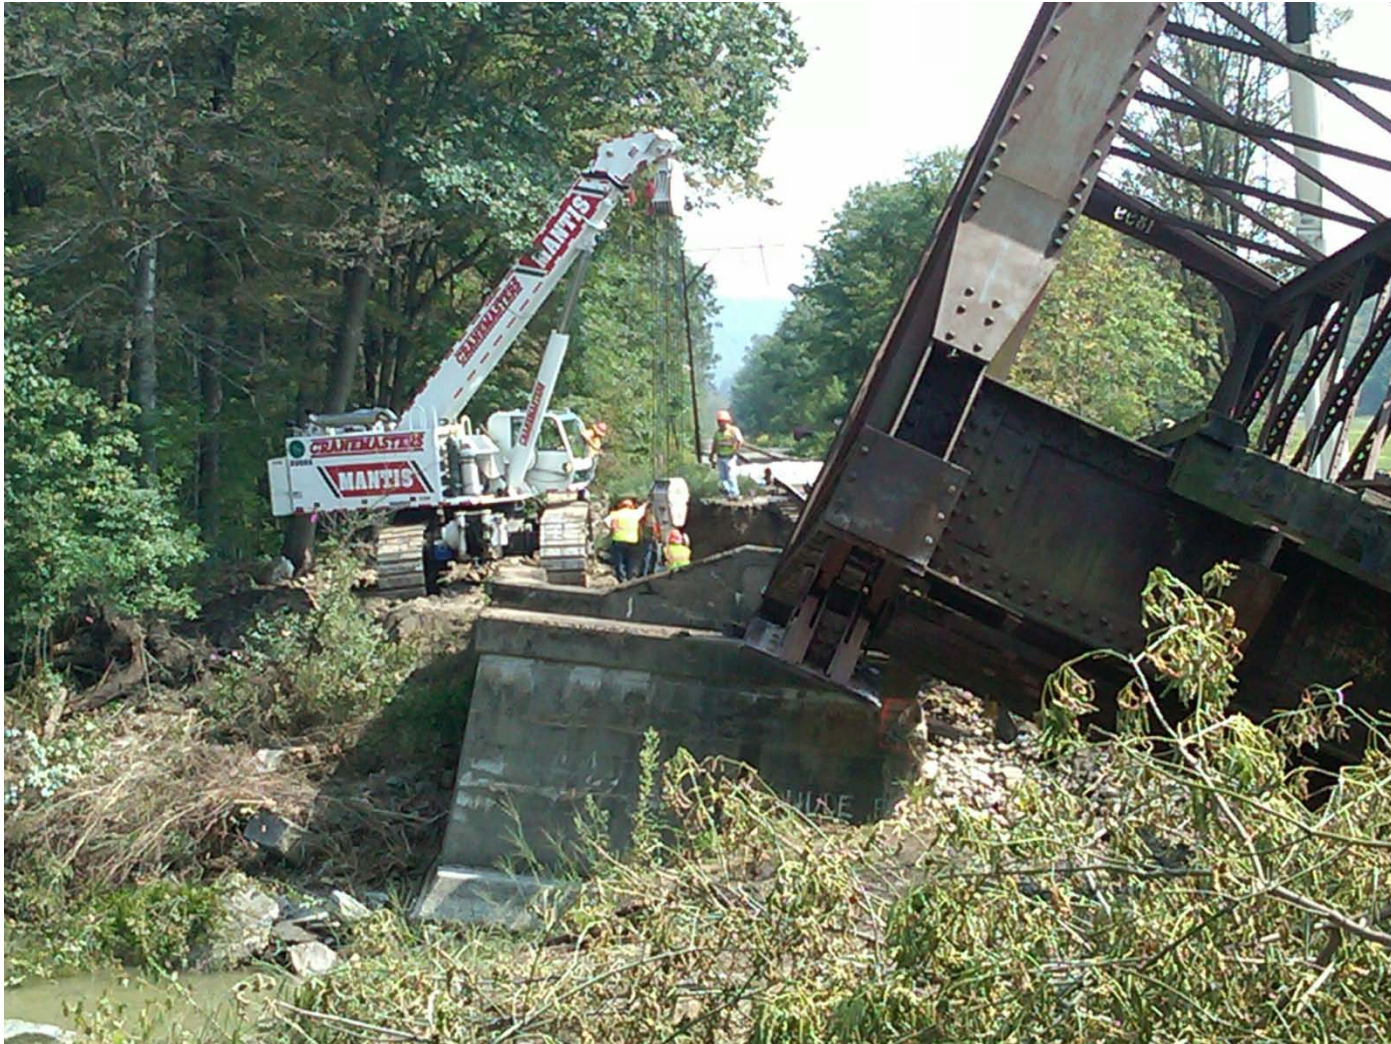
Setup Cranes

Saturday – September 3

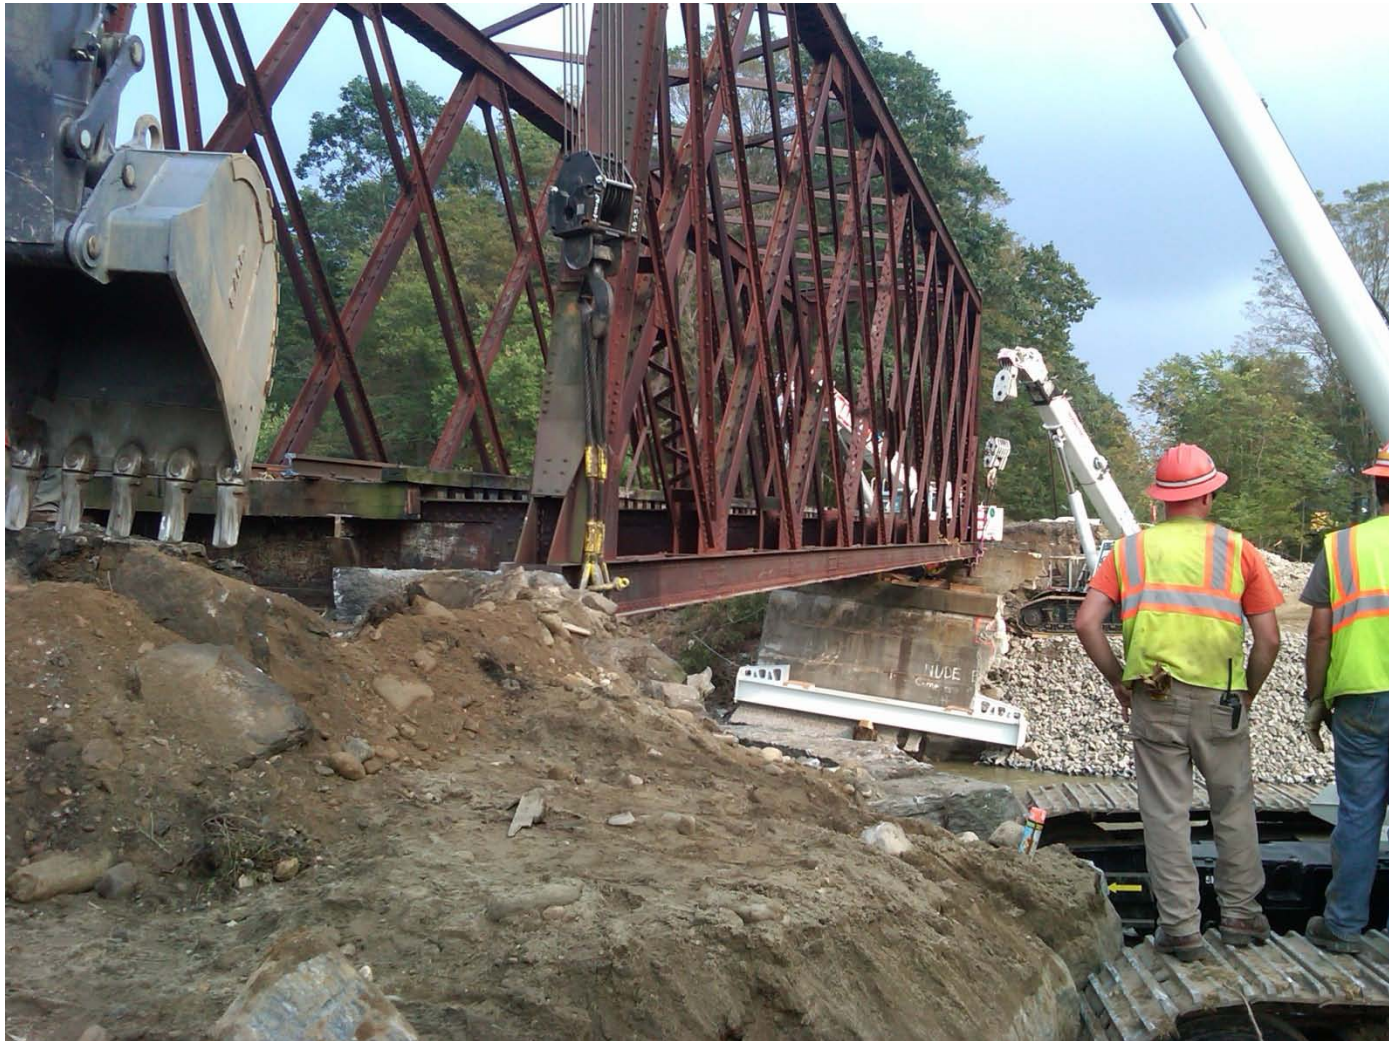
Bridge Brought to Vertical & Secured Sunday – September 4

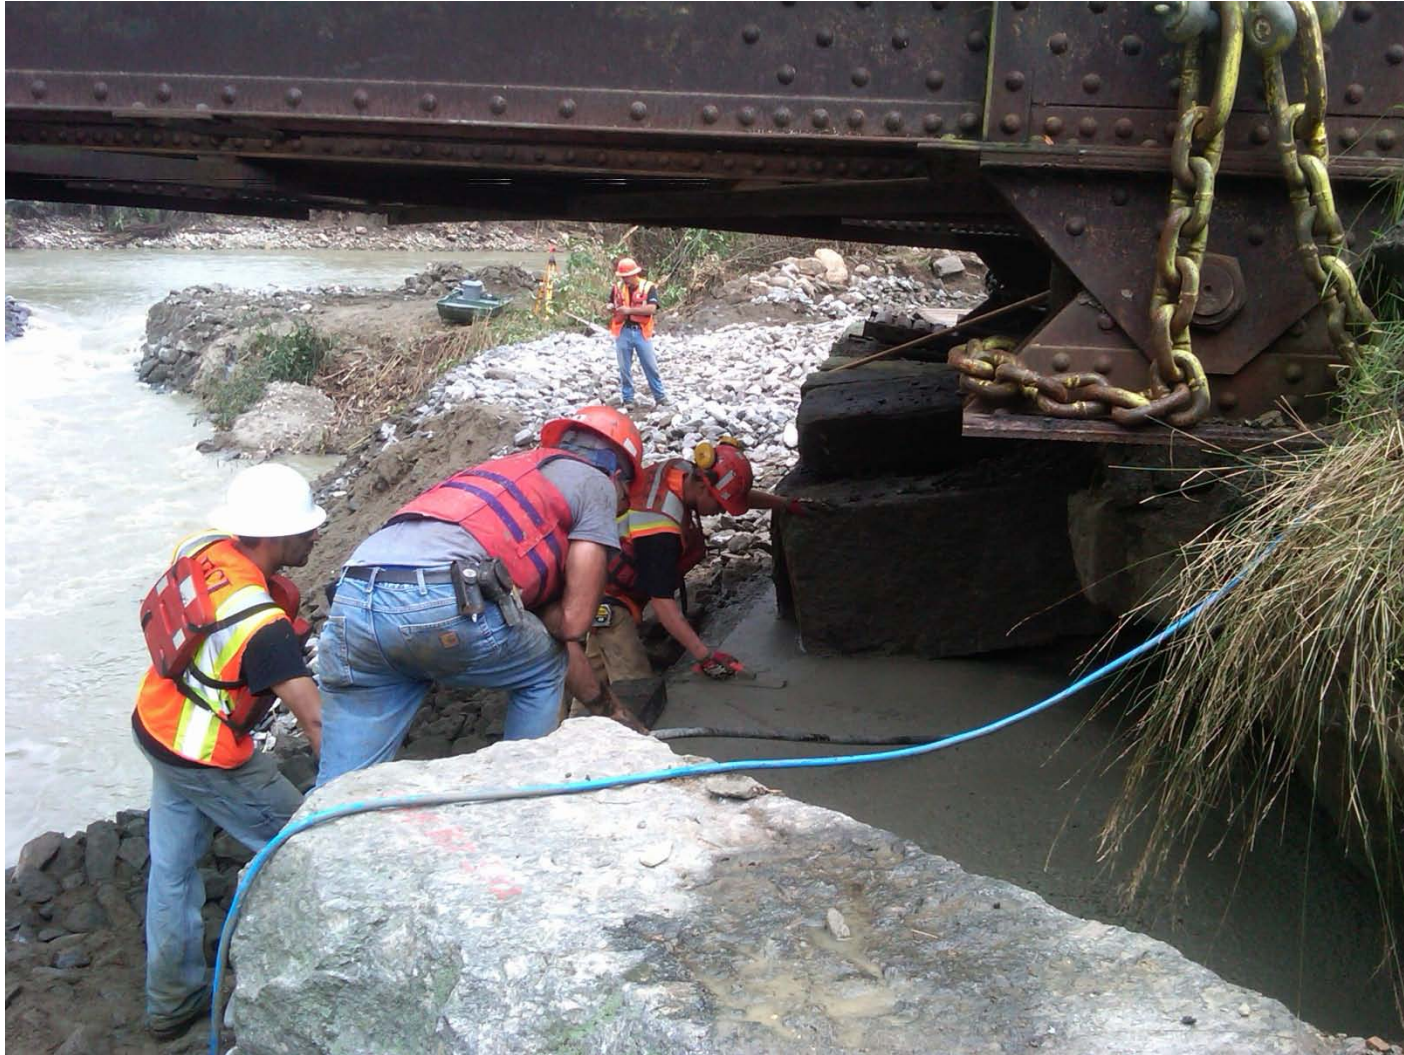
Stabilize West Abutment Monday - September 5

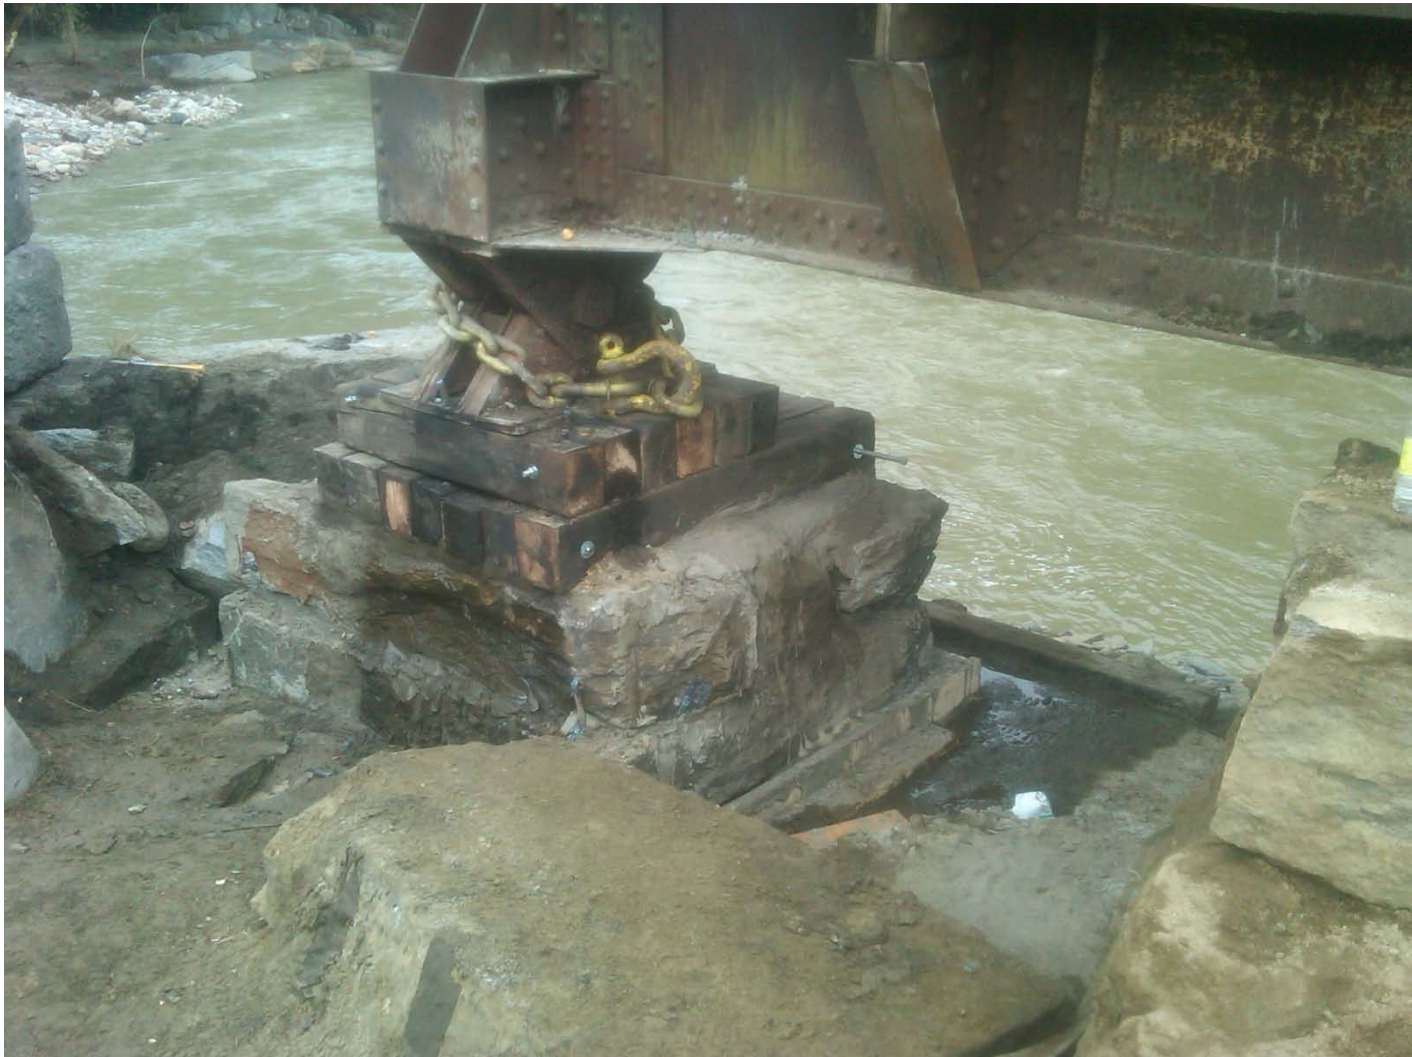
Install Pedestal at NW Bearing Tuesday – September 6

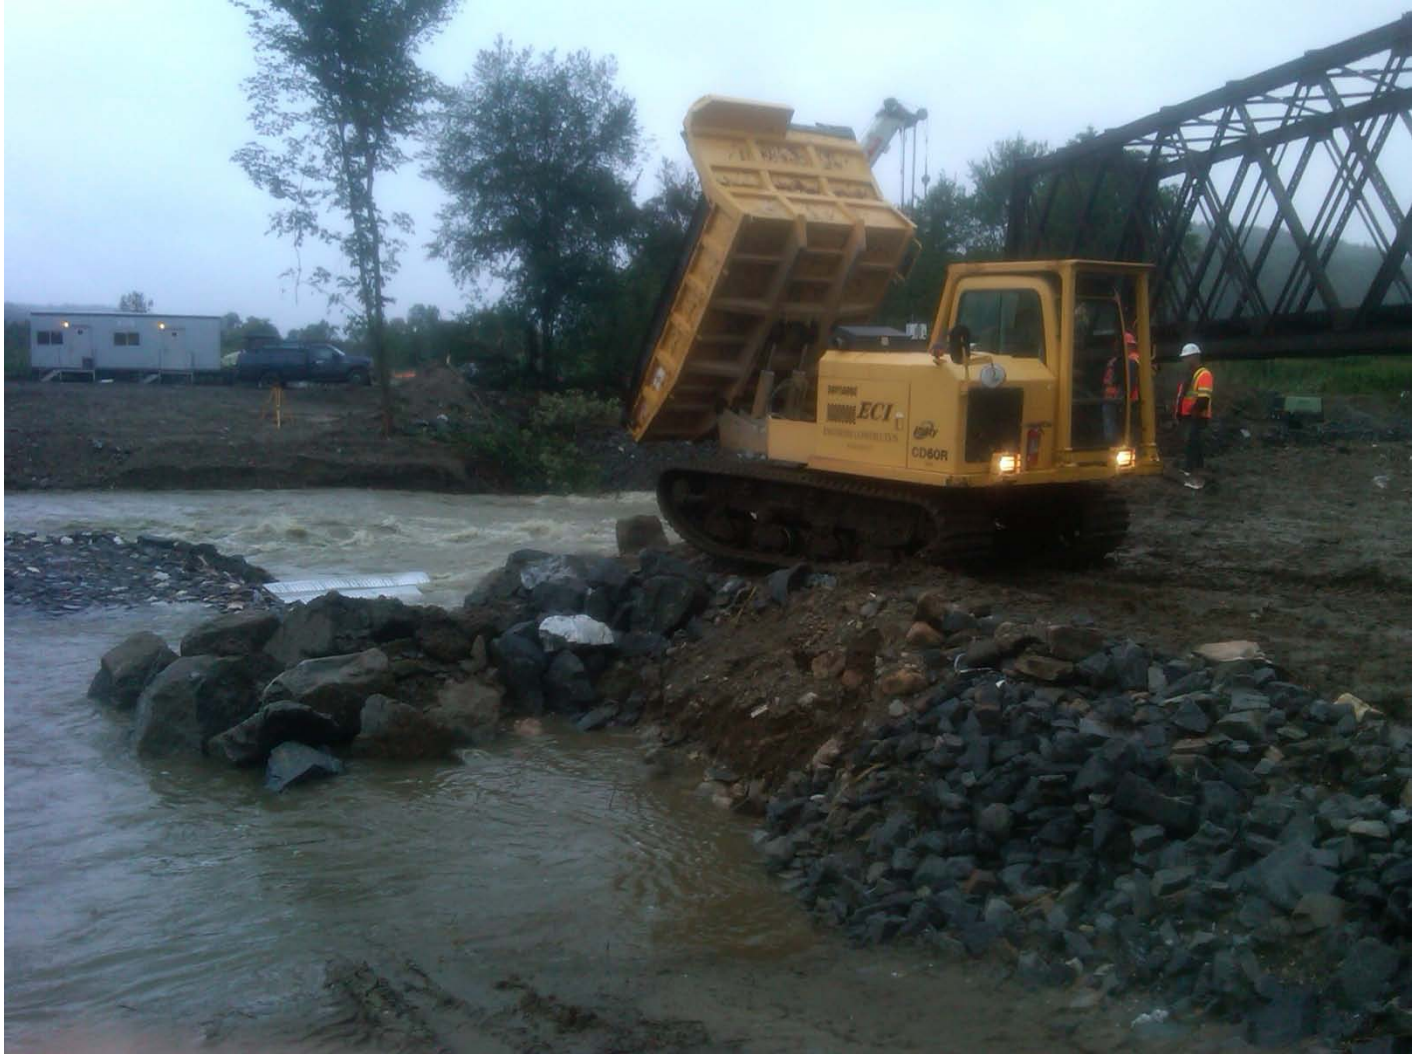
Secure Work from Tropical Storm Lee Wednesday – September 7

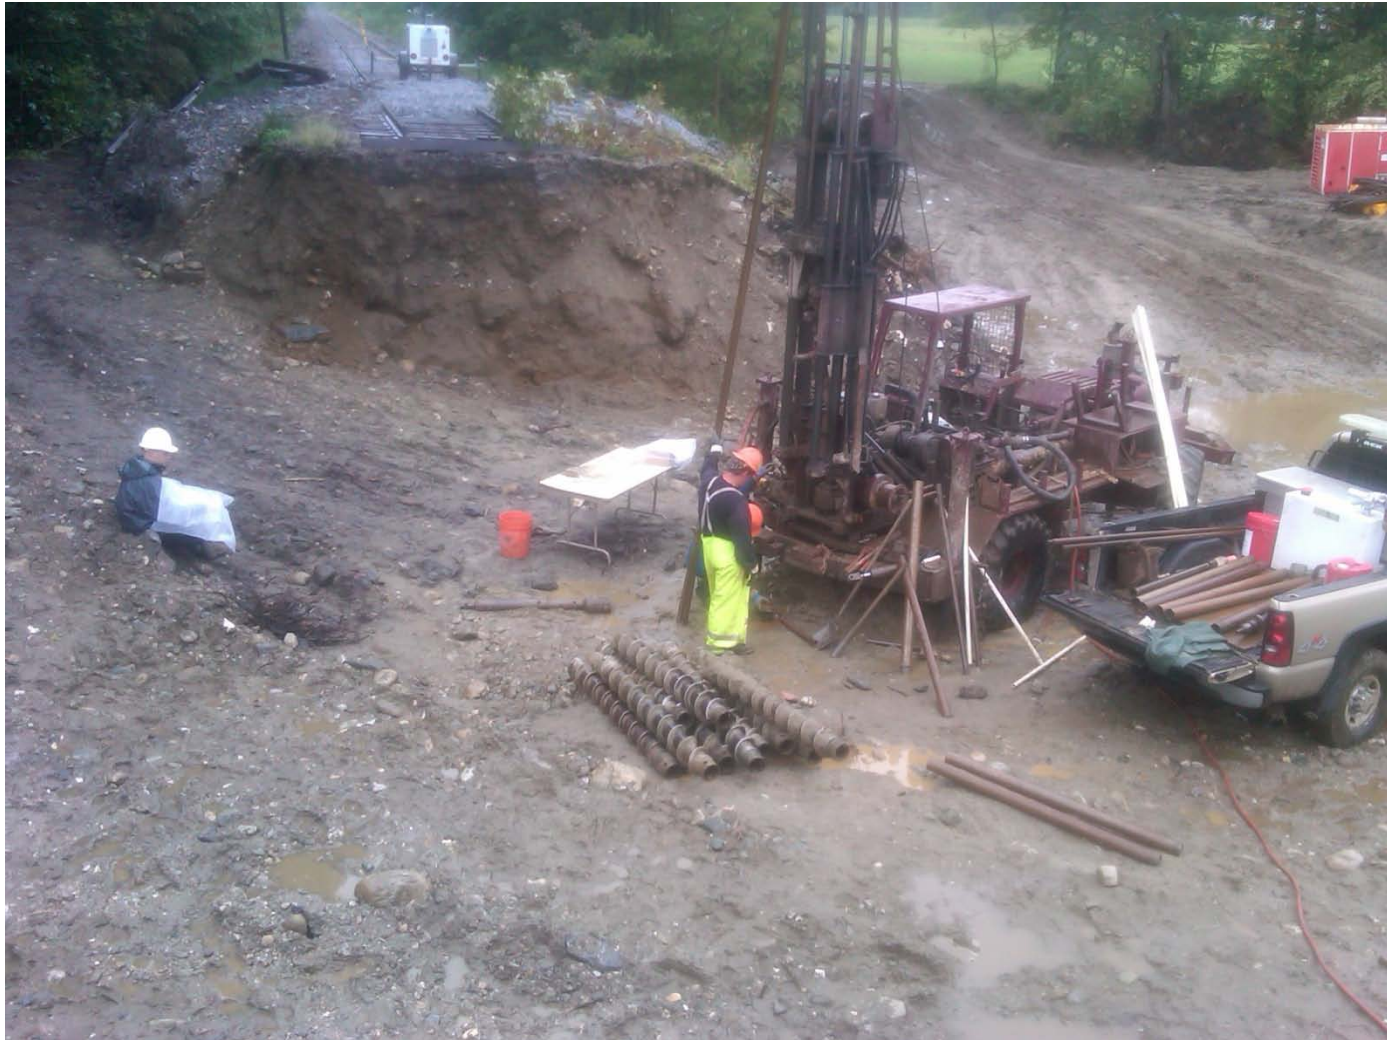
Test Borings at East Abutment Thursday – September 8

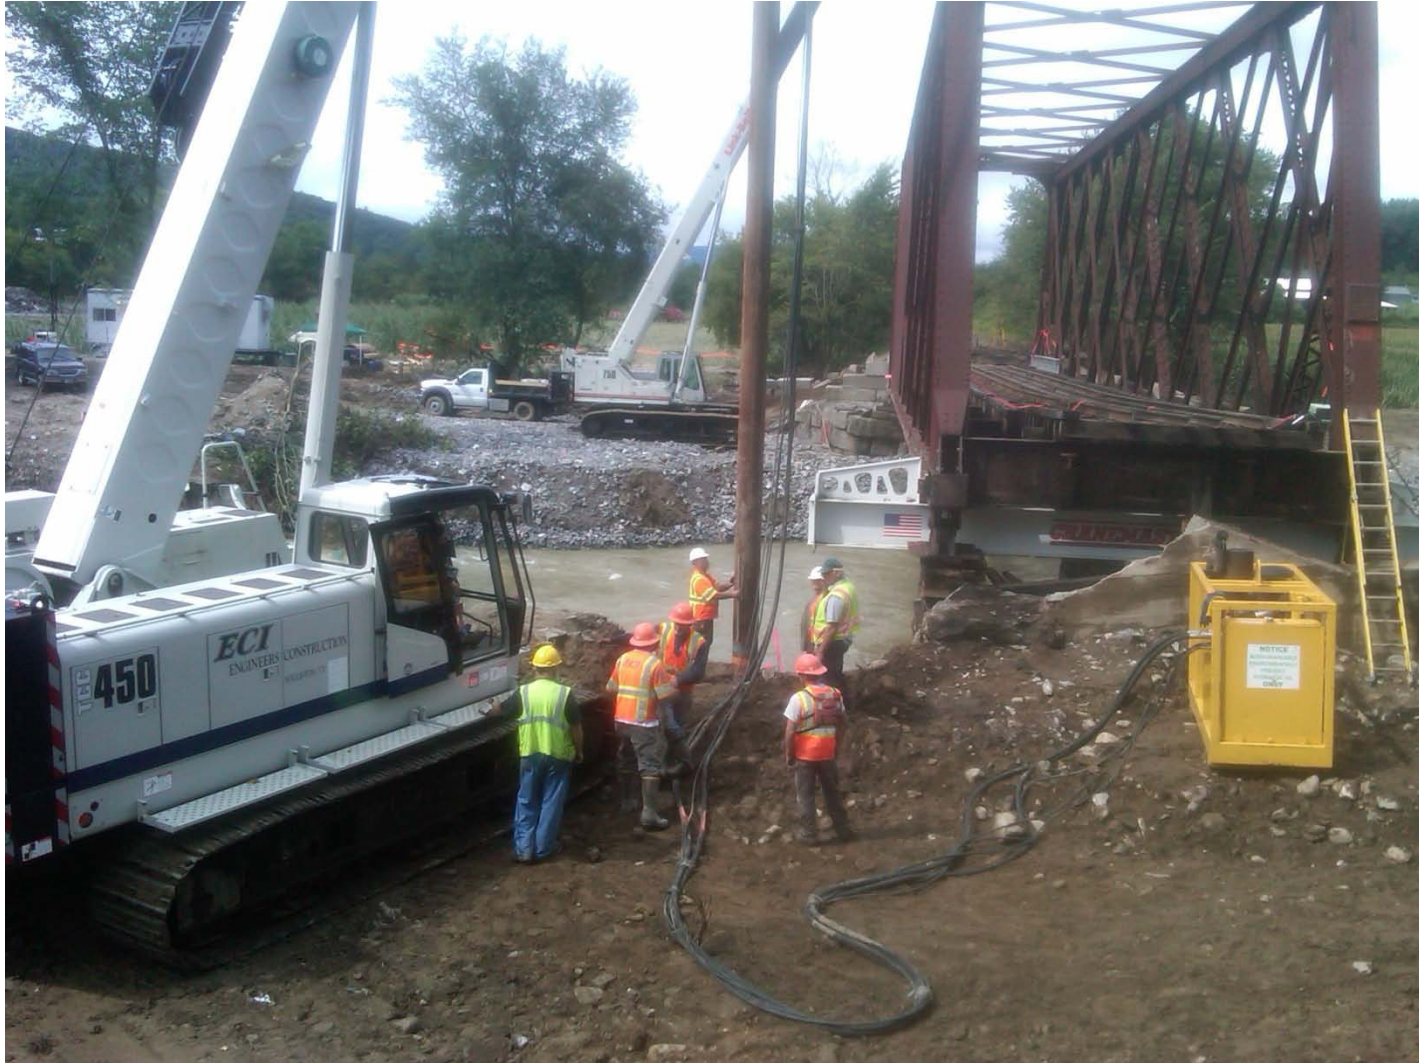
Start Driving Pipe Piles

Thursday – September 8

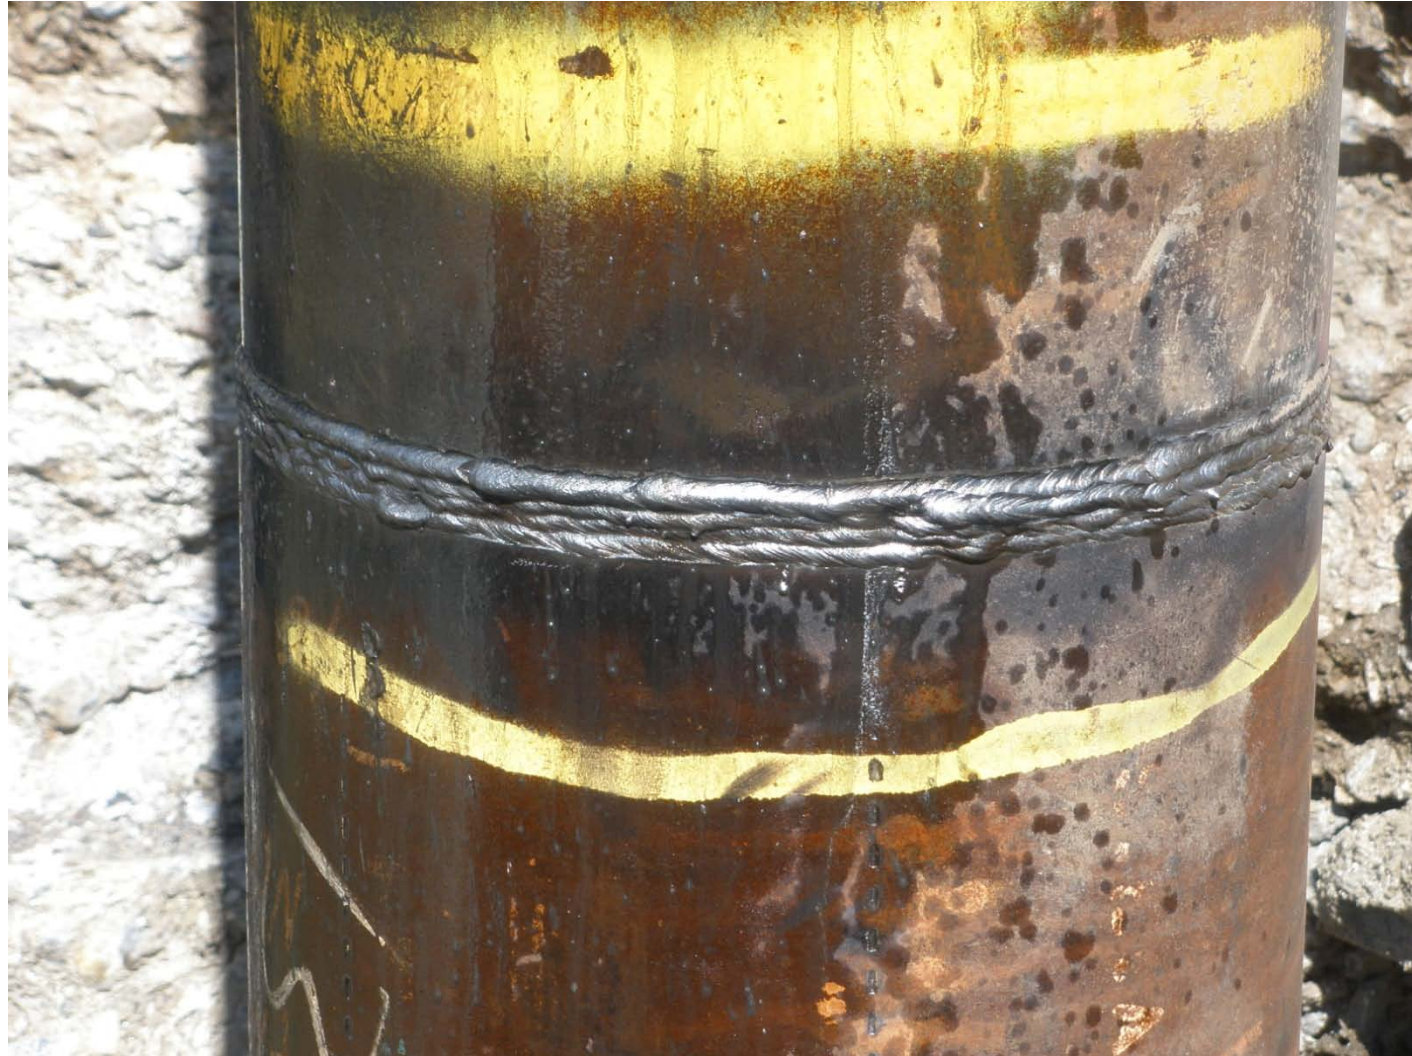
13.75-in-OD x 0.707-inch wall Pipe Pile Splicing – 2 hrs/joint

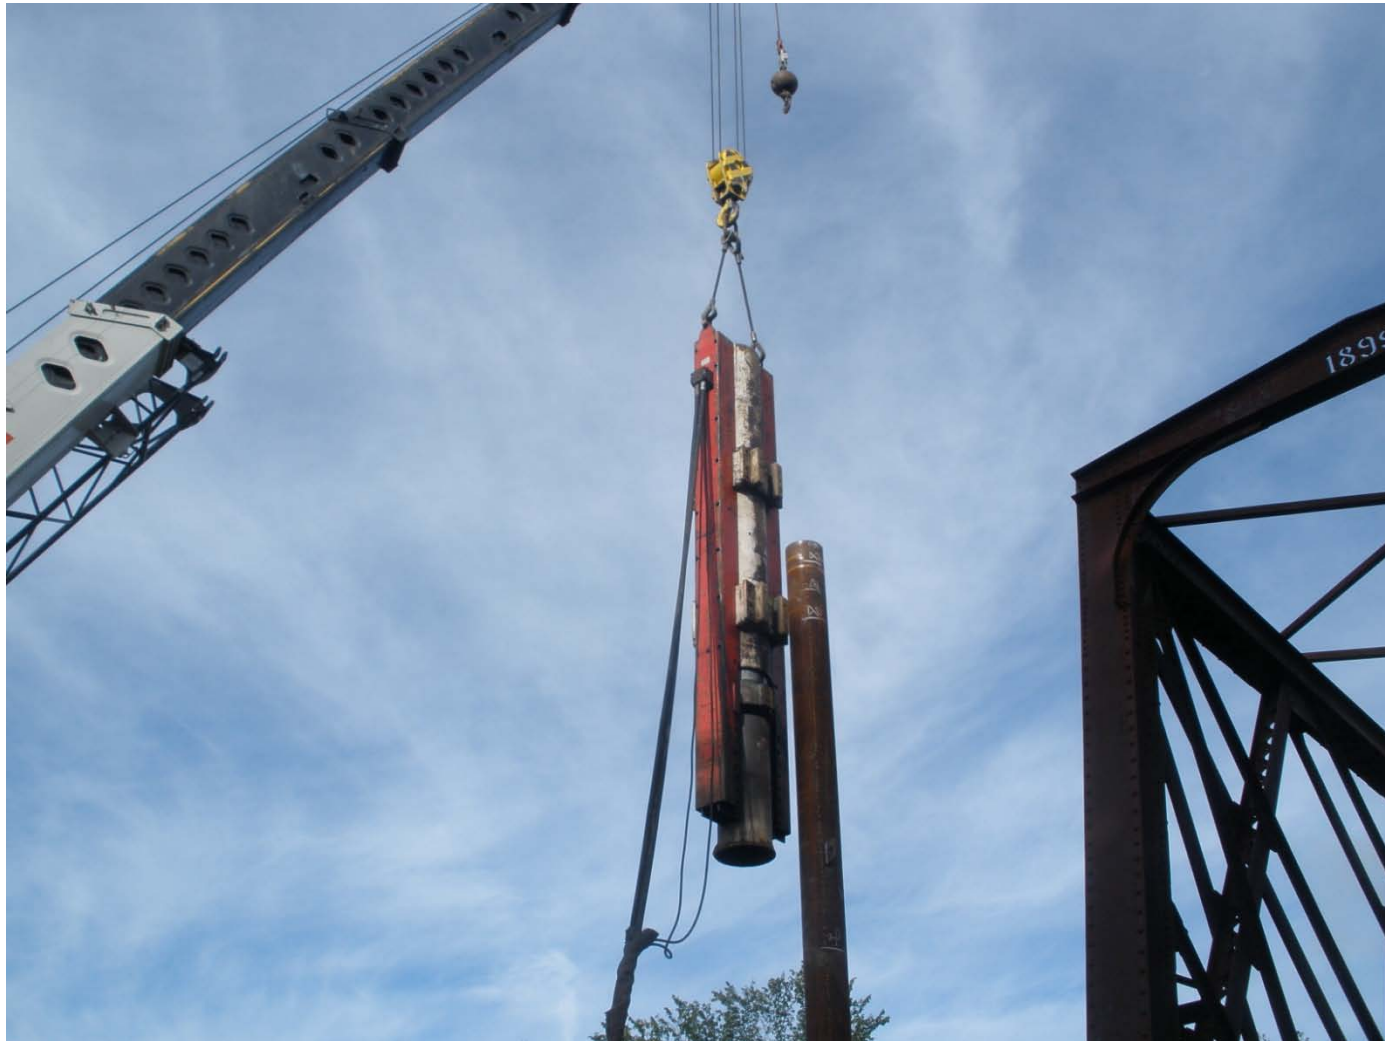
Final Driving of Pipe Piles Saturday – September 10

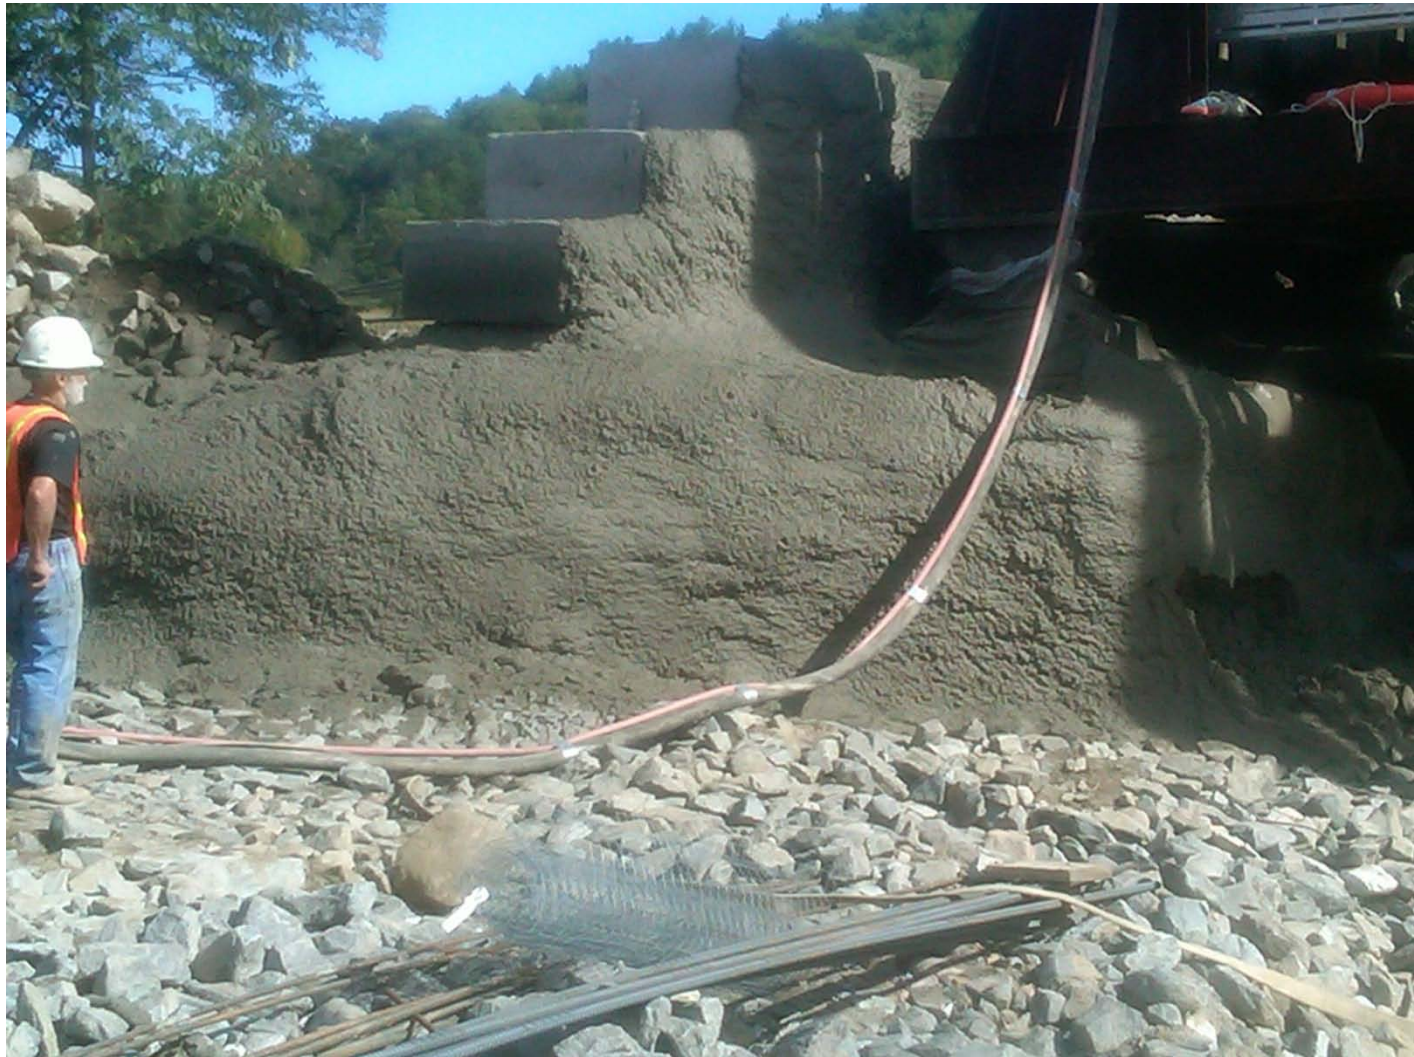
Shotcreting of West Abutment Sunday – September 10

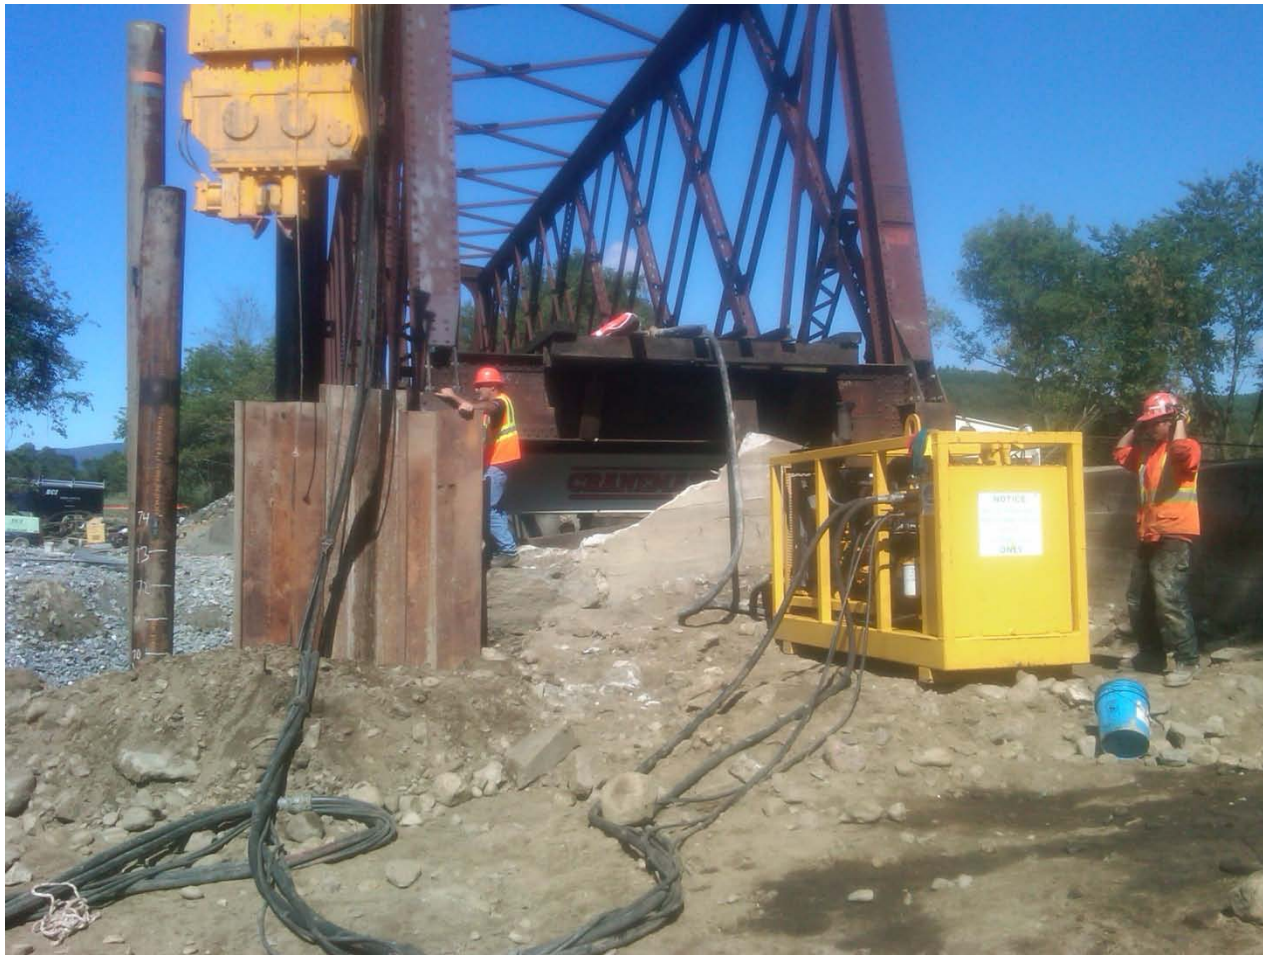
Sheet Pile Wall to Extend Damaged West Abut

Sunday - September 10

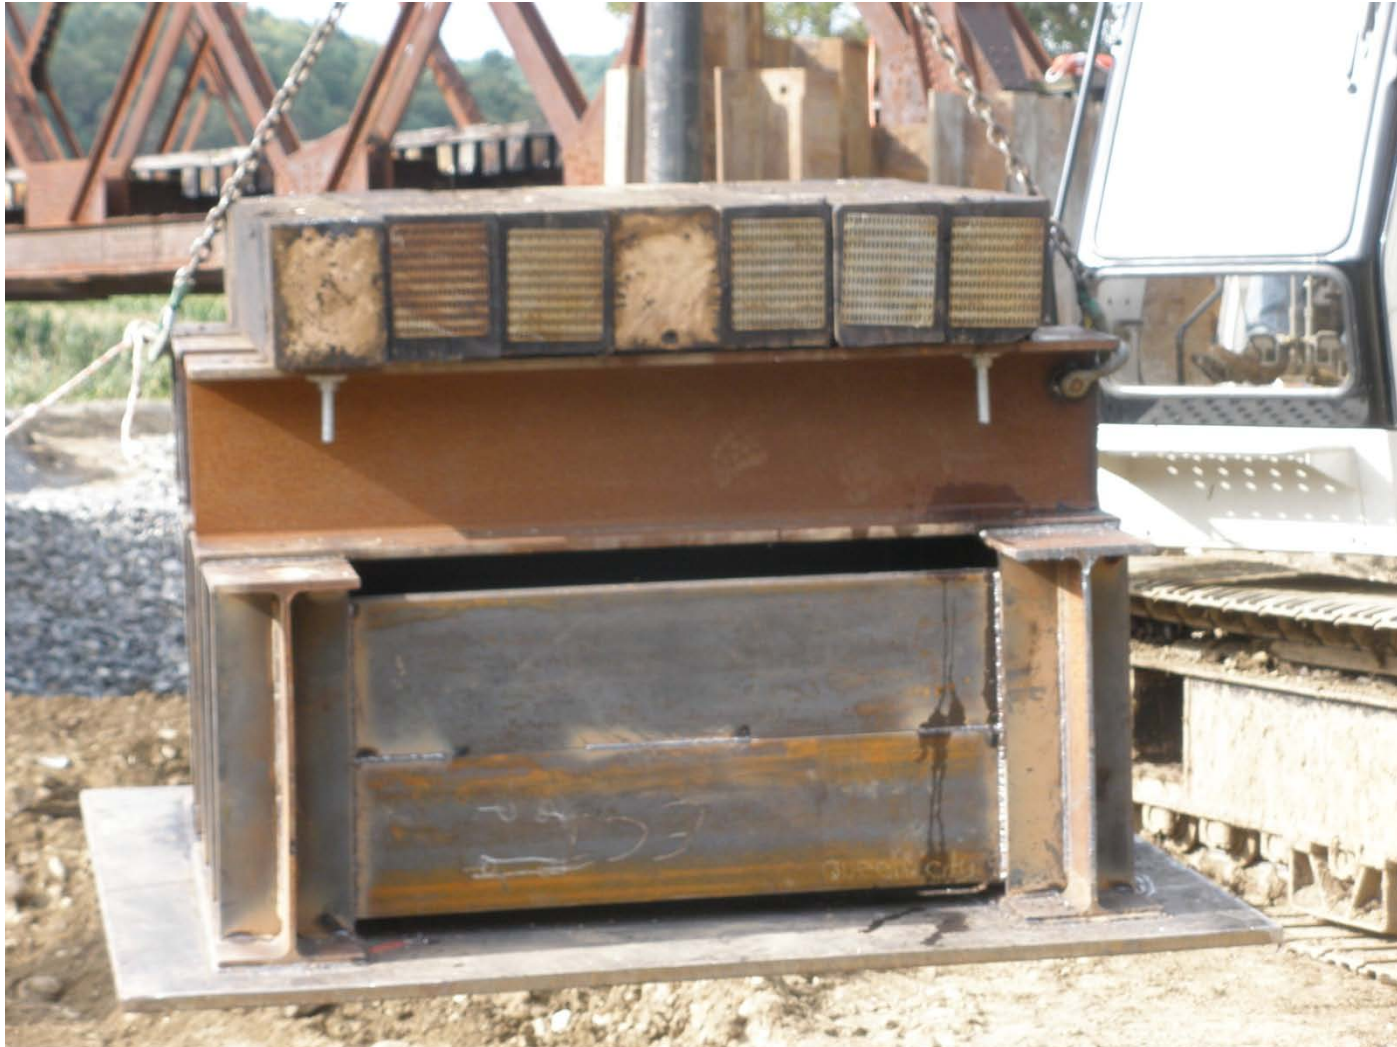
Temporary Bearing Pedestal Sunday - September 11
