GMRR Bridge #114
Tropical Storm Irene Emergency Repairs
Chester, Vermont

ECI Rail Constructors, Inc.
September 2011

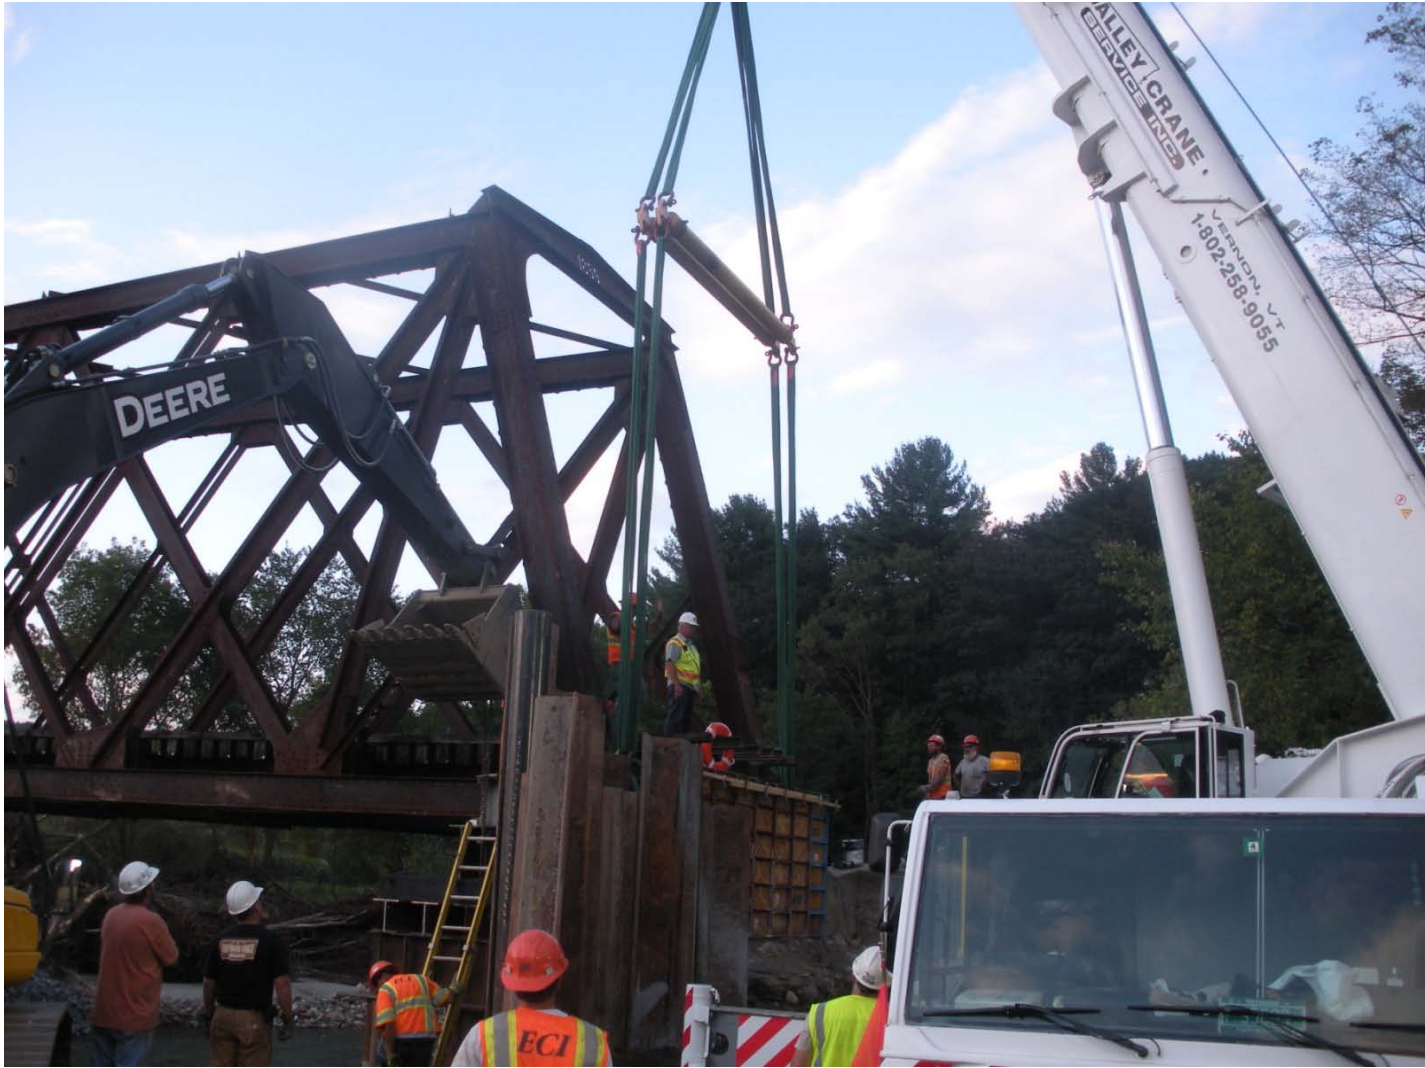
Setting Bridge on Temporary Bearing Supports

Sunday - September 11

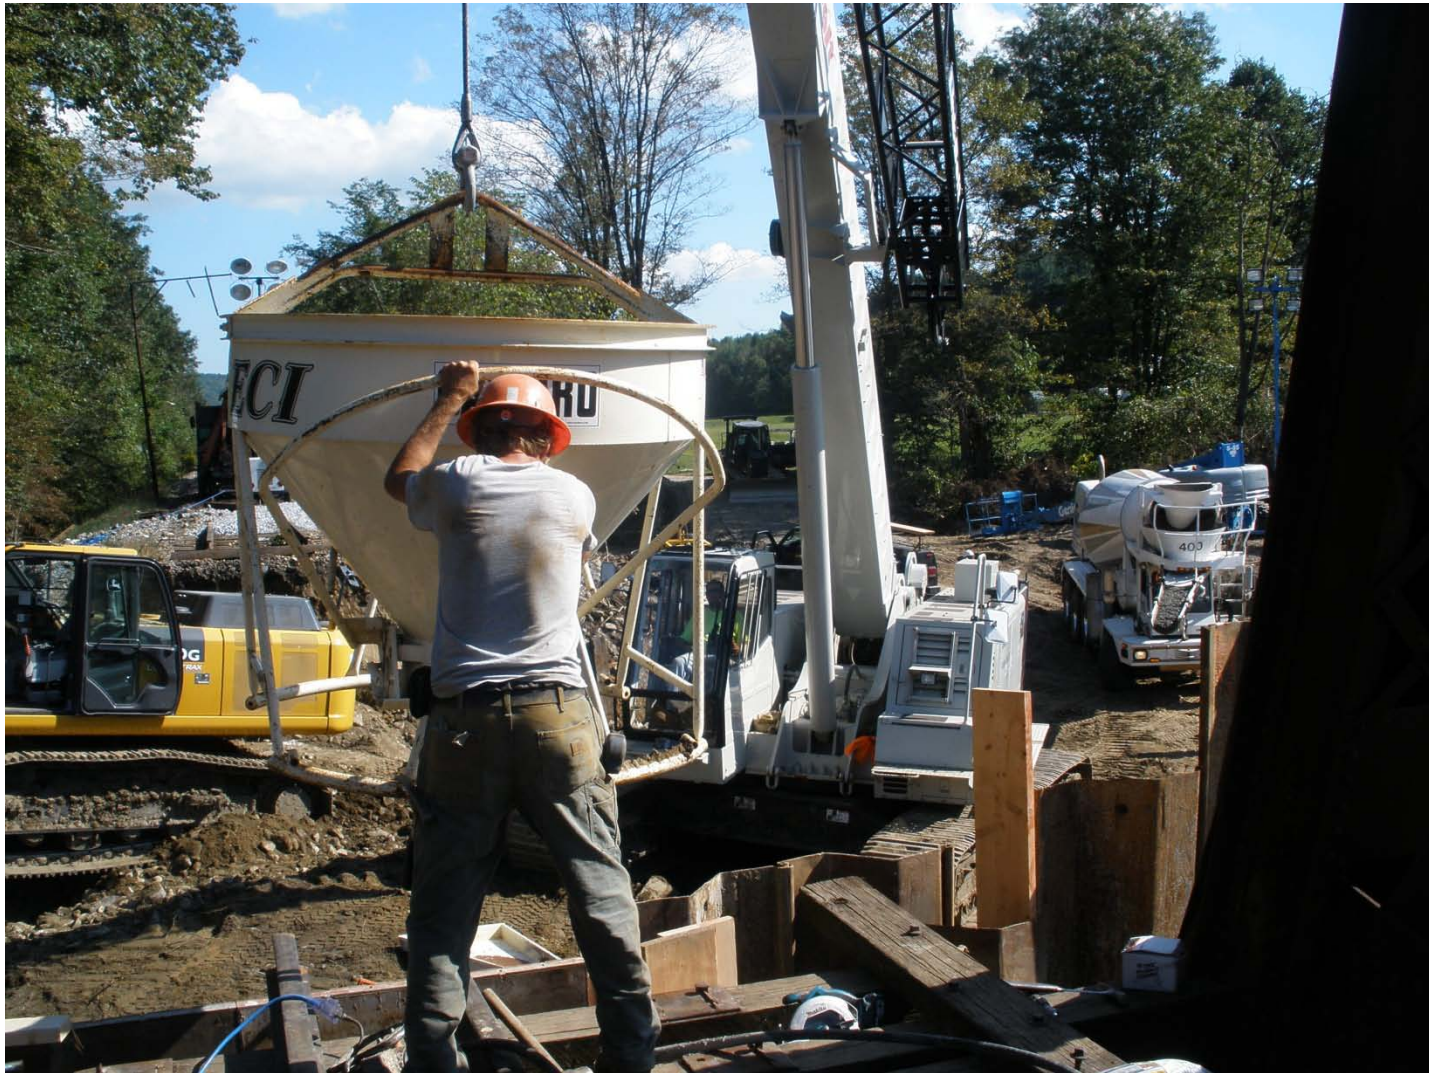
Pouring Concrete Backwall & Abut Extension

Monday – September 11

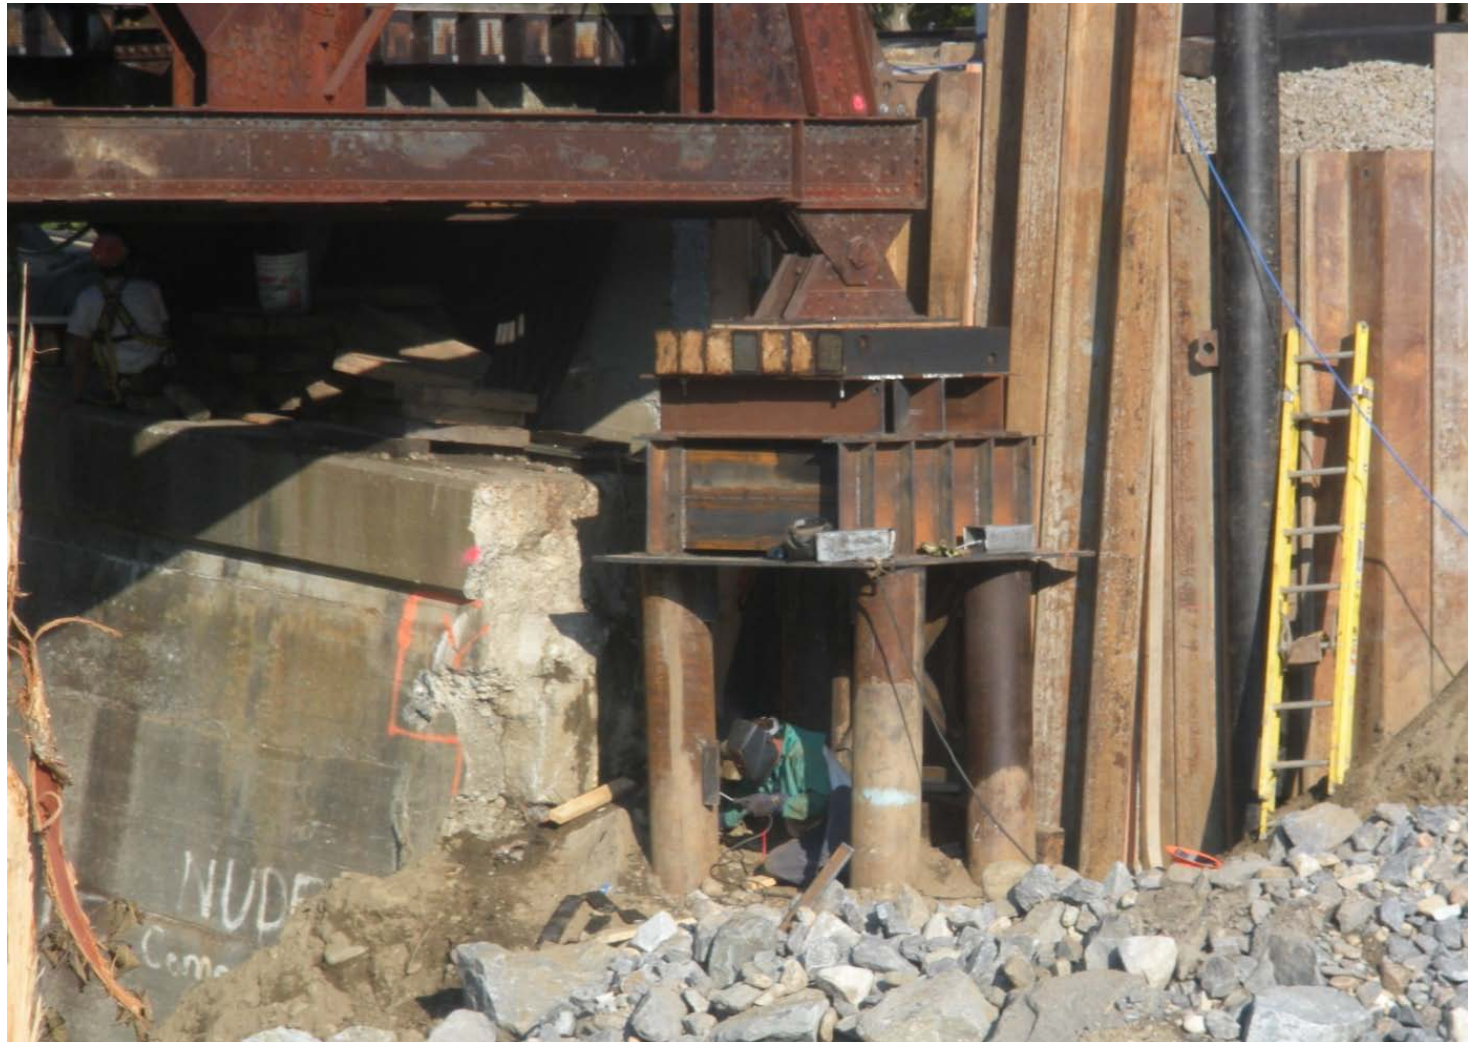
Final Welding & Bracing of Piles & Pedestal Tuesday – September 13

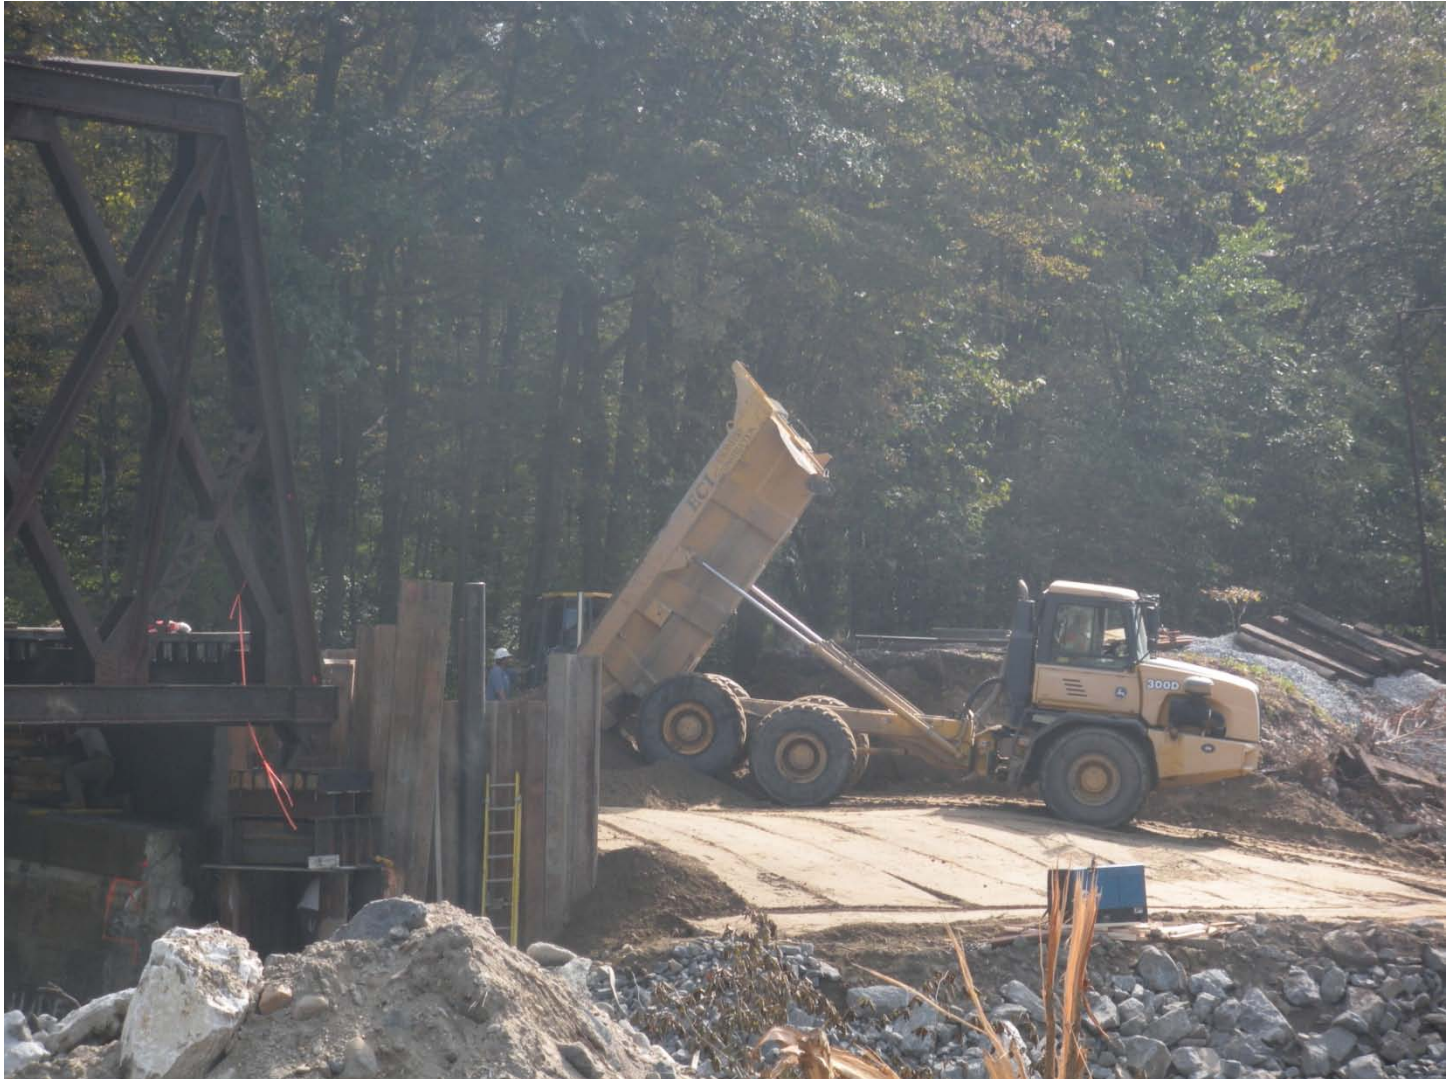
Rebuilding Approach Embankment Tuesday – September 13

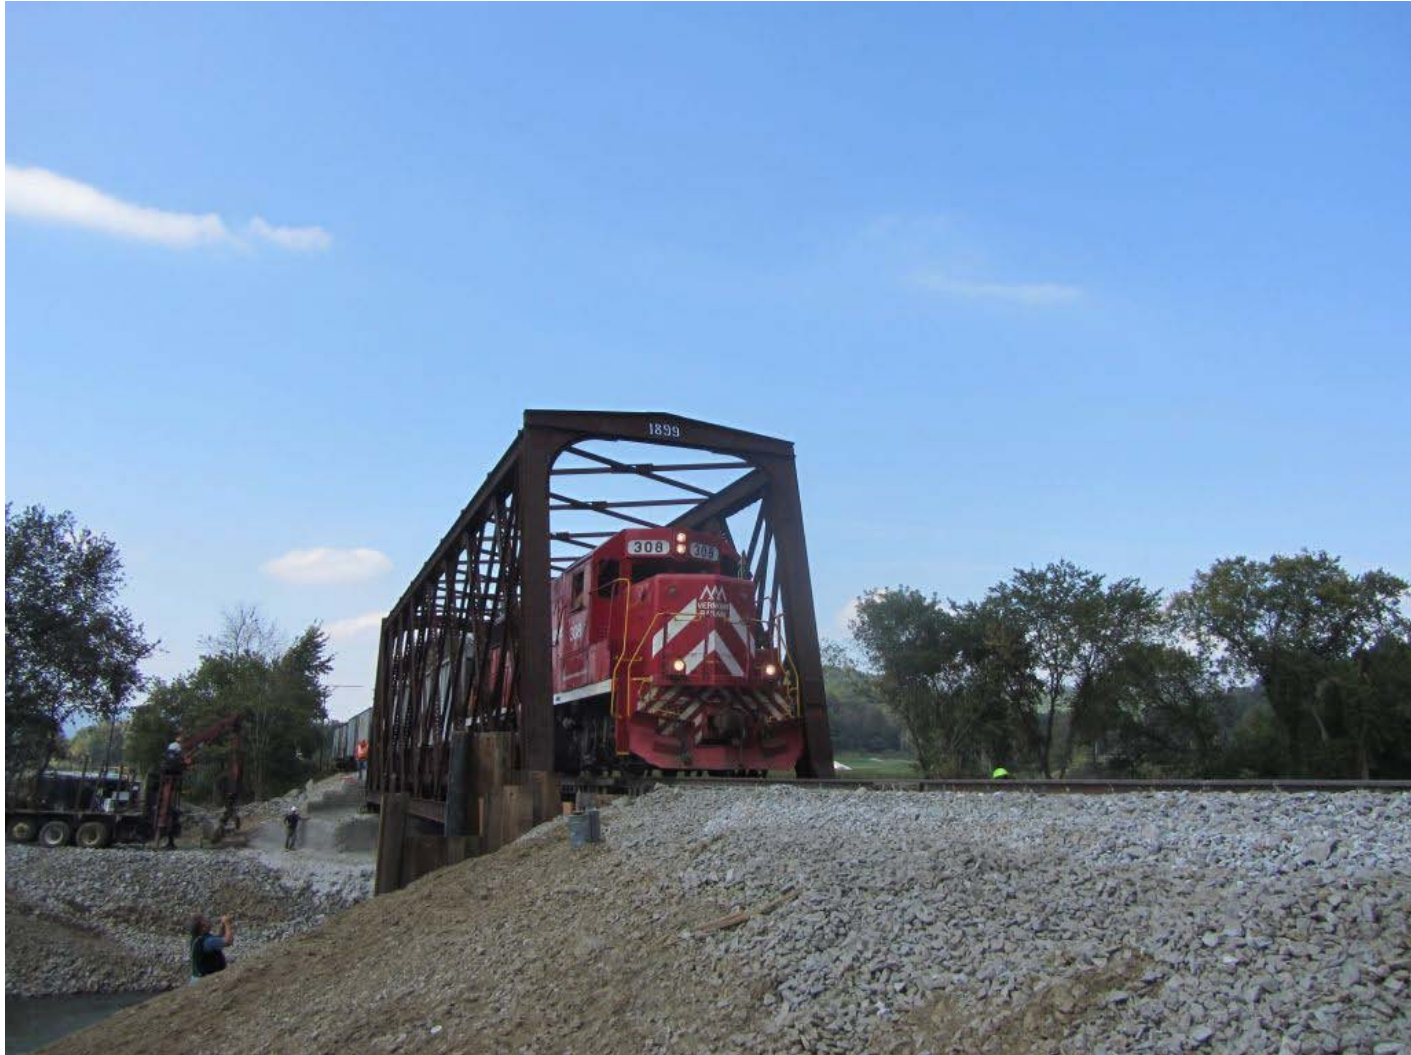
First Train

Wednesday – September 14
