BURLINGTON TUNNEL EMERGENCY REPAIRS: A CASE HISTORY

Kenneth A Pidgeon, PE

ECI Rail Constructors, Inc., Burlington, VT

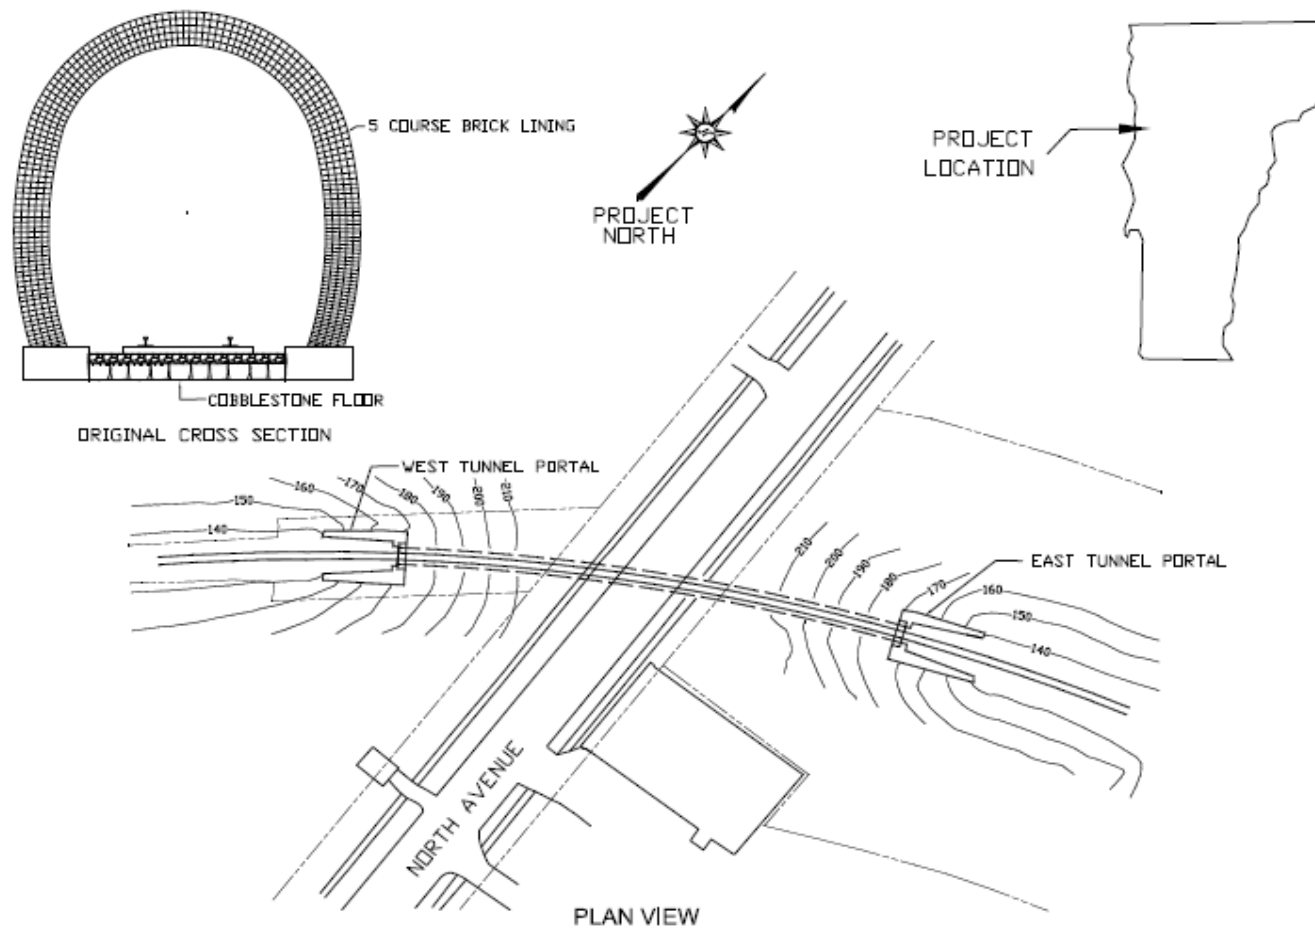
The tunnel is brick-lined with about 18.0 m (60 ft.) of overburden. The tunnel configuration is elliptical horseshoe shape as depicted in the cross-section shown in Figure 1. This original brick lining is six wythes (layers) thick and constructed with mortared joints. The brick lining is supported on cut limestone blocks (henceforth referred to as wall footings) and prior to the 2008 shotcrete work, a cobblestone floor served as horizontal bracing between the footings supporting the walls. The ballast and wood cross-tie track structure had been supported on the cobblestone floor. The portals consist of mortared cut stone with wing walls of similar construction. Figure 2 shows a photo of the west portal.

Figure 1. Project location, plan view and original cross-section

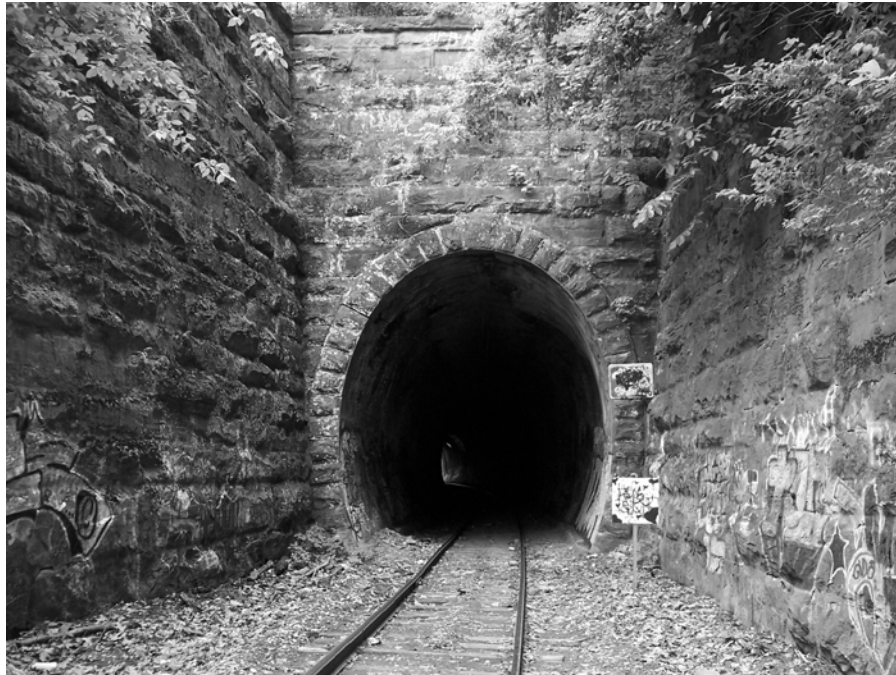
Figure 2. West portal in 2007
